# COADAPT

- Dune Erosion and safety along the Lodbjerg-Nymindegab Coast Denmark

November 2013

<b>Rapport</b>	<b>Dune Erosion and Safety along the Lodbjerg-Nymindegab Coast Denmark</b>
Forfattere	Matthew Edward Earnshaw Holger Toxvig Madsen
Nøgleord	
Distribution	<a href="http://www.kyst.dk">www.kyst.dk</a> , Miljøministeriet, <a href="http://www.dab.dk/anmeld.asp">www.dab.dk/anmeld.asp</a>
Refereres som	Earnshaw. M. E. og Madsen. H. T., 2014 Kystdirektoratet, Lemvig.

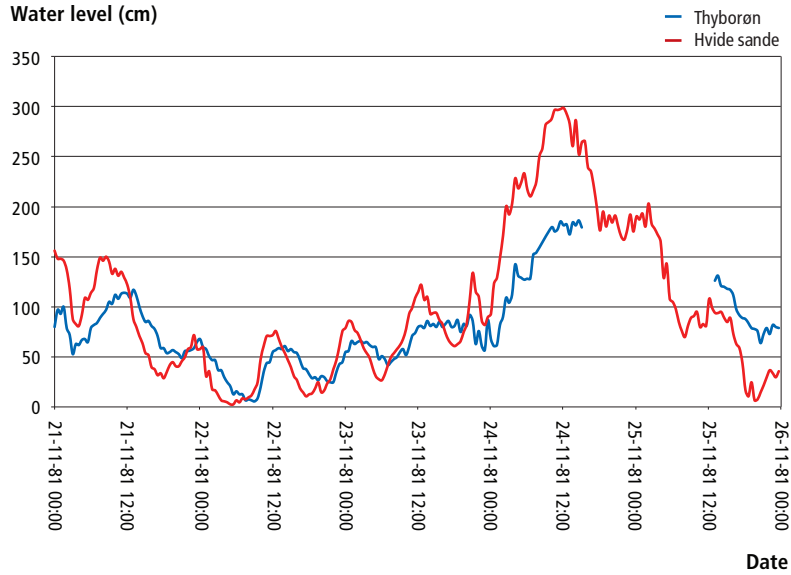
Fig. 3.3.4 1981 Storm water levels

Unfortunately the data for this storm was only completely available for the port of Hvide Sande.

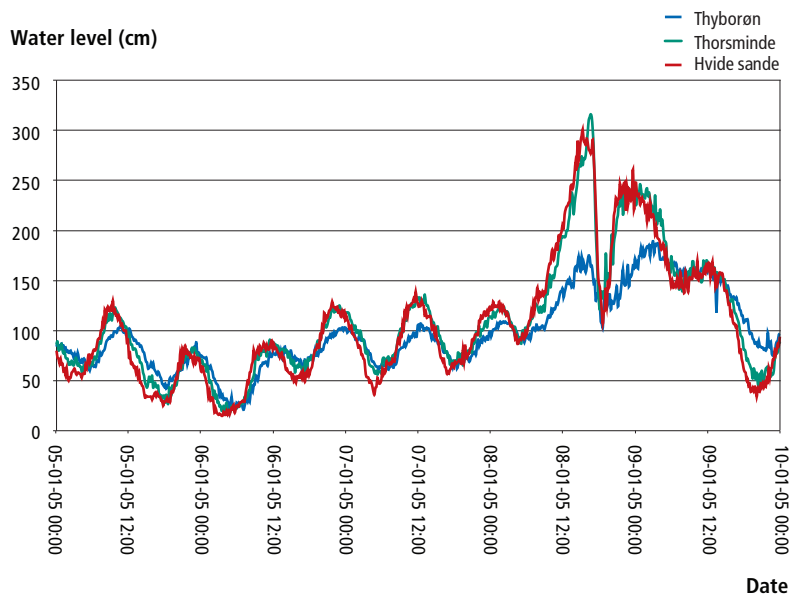
Fig. 3.3.6 2005 Storm water levels

It can be clearly seen that the water level during each storm varies between the three measuring stations. It is also apparent that the duration of the high water level varies from location to location. As erosion should also be a product of storm duration as well as its ultimate high water level a comparison of storm duration can be made to offer a little more insight into the erosive potential of each storm. The amount of time the water level was above that of a 5 year return period was calculated for each storm in each measurement location. This can be graphically viewed below.

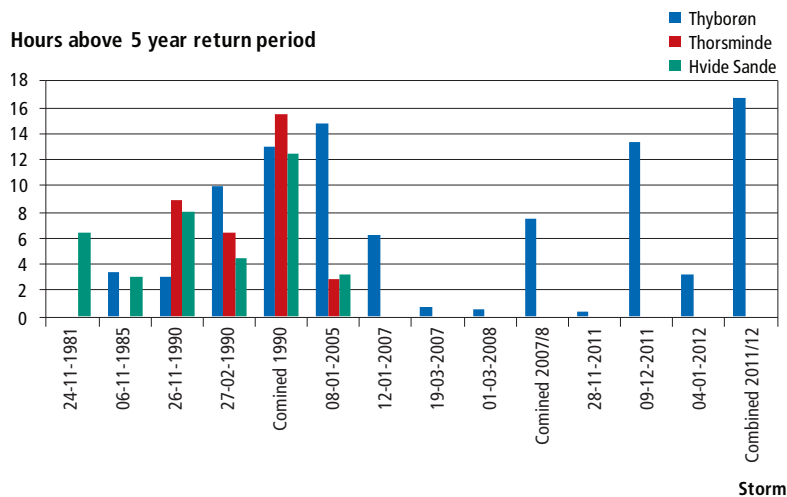
Fig.3.3.7 Storm duration graph

Unfortunately water level data was only available in complete form from Hvide Sande for the 1981 storm, therefore it is difficult to fairly compare the duration of the 1981 storm with that of the storms in 1990 and 2005. Because the two storms in 1990 were so close together they have been combined here into a single storm. It can be seen that in Thorsminde and Hvide Sande the 1990 storm had a much longer duration in comparison to the 2005 storm although in Thyborøn durations were much the same. From Hvide Sande at least it can be seen that the duration of the 2005 storm was around half that of the 1981 storm and around a quarter of the 1990 storm. The large storm in 2007 only significantly affected Thyborøn and here it can be seen that it did not feature a particularly long duration. The winter of 2011/12 was also similar in that water levels with a high return period were only experienced in Thyborøn however when combined these storms exhibit the longest duration.

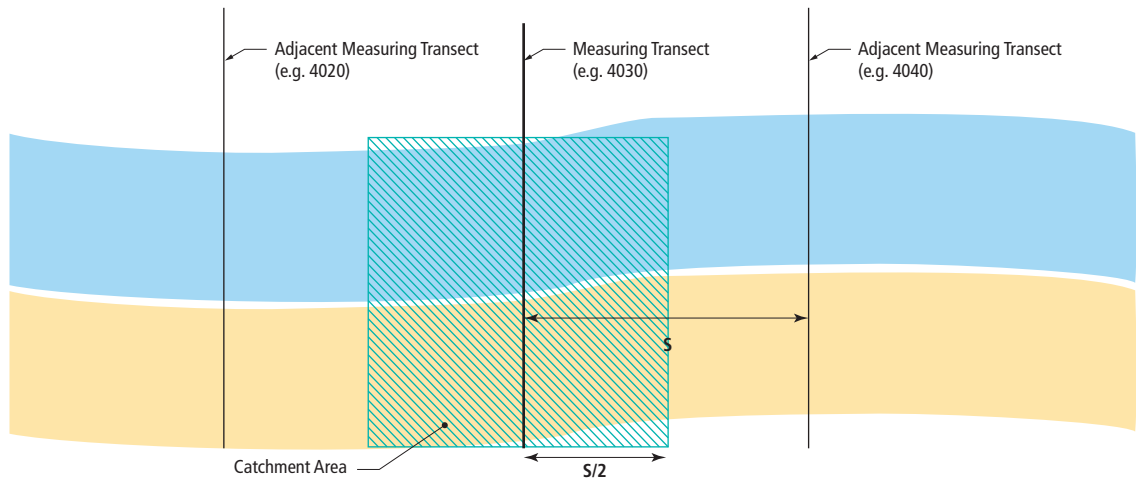
Fig. 3.5.1 Nourishment calculation area

The volume that has been deposited in this area can then be divided by the sections spacing ( $S$ ) to give a deposition volume per meter of coastline. For the purposes of this study the effect of any nourishment sand deposited in this area is assumed to lie uniformly distributed between a height of 4m above sea level and a depth of 6m below sea level (see Fig 3.5.2).

contains the date and volume of sand deposition in a catchment area spanning either side of the measuring transect in question and is simply described in figure 10 below.

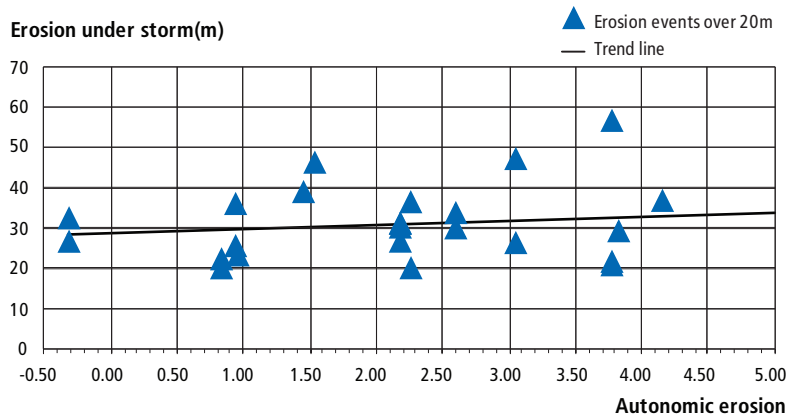
Fig. 9.0 Autonomic erosion against large storm erosion events

The graph above (Fig. 9.0) shows a correlation between the autonomic erosion at each site and the largest erosion occurrences. A slight correlation can be seen however based on the information available here it can be safely concluded that the autonomic erosion rate of a particular location does not offer a convincing solution for the occurrence and size of these large erosion events.

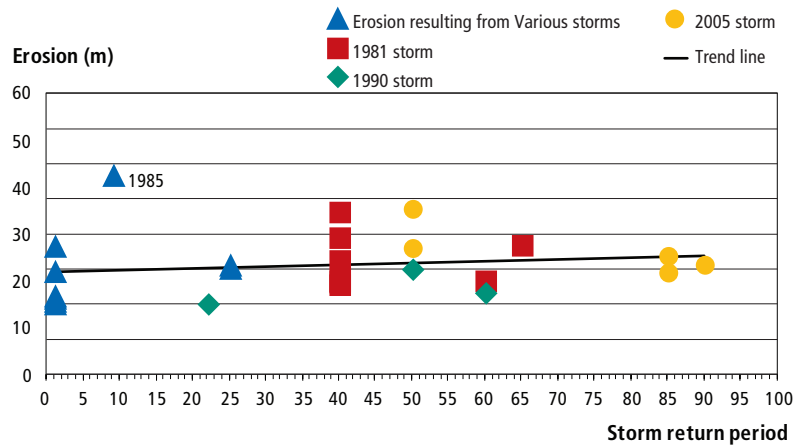
Fig. 10.0 Large dune erosion events 1977-2012

The above graph summarises all of the large dune erosion events that were found and quality controlled within the context of this project. Figure 10.0 above shows the erosion events with a correction for sand nourishment. It can be seen that the large erosion events resulting from each storm are all on a relatively even level with little apparent signs of an increase in erosion in relation to sea level. Sand nourishment can be seen to be the largest significant change that has occurred over the investigated period with a greatly increasing effect in more recent times. In figure 10.01 below the erosion events from figure 10.0 are displayed but this time without a correction for sand nourishment. A large effect can be seen on the more recent erosion events in particular it can be seen that all of the erosion events recorded after the 2005 storm drop down the graph considerably and as a result showing an inverted correlation between storm return period and dune erosion distances. This shows that actual dune erosion that is experienced after significant storms has been reducing despite there being some extremely high sea levels over the last decade.

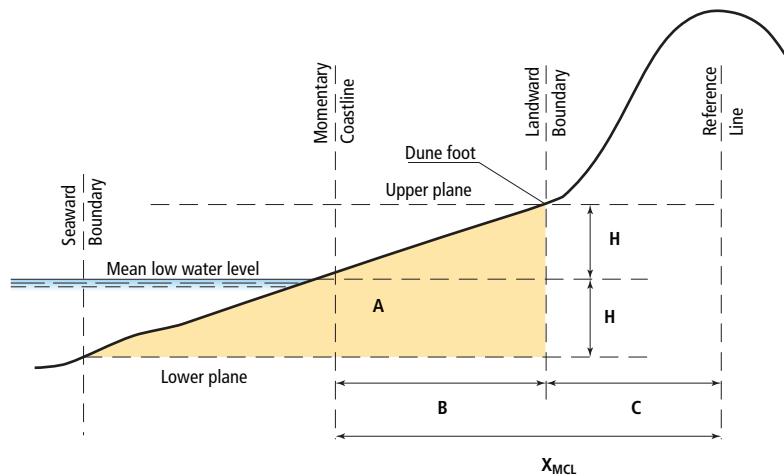
$H$  = Height between dune foot and mean low water [m]  
 $A$  = Momentary Coastline Zone [m<sup>2</sup>]  
 $B = A / 2H$  = Momentary Coastline position [m]  
 $C$  = Distance dune foot to reference [m]  
 $X_{MCL} = B + C$  = Momentary Coastline position + Distance dune foot to reference [m]

Fig. 11.0 Momentary coastline diagram (Mulder, 2004)

In further detail the yearly monitoring uses a Momentary Coastline – MCL. This coastline position is based on a calculation of the volume of sand in the near shore zone (see Fig. 11.0). If  $H$  is the vertical distance between the dune foot and the mean low water level the MCL is calculated as the mean position of the profile between an upper plane  $H$  above the mean low water level and a plane  $H$  below the mean low water level. The mean position is based on calculation of the sand volume between the two planes (Mulder, 2004)
