COADAPT

- The evolution of a beach nourishment at Blåvand

Blåvand, Denmark

December 2014

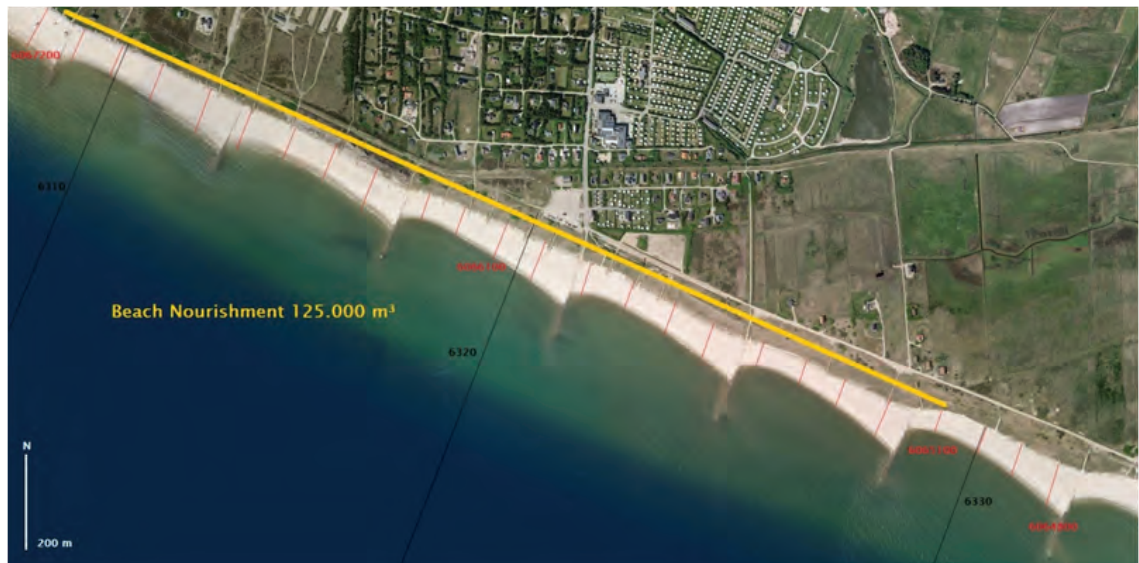
Figure 3.1. Nourishment site with survey lines (red), nourished area (on the beach in length marked by yellow line) and DCA survey lines 6310 - 6330 (black).

The survey data consists of 22 survey lines (lines 6064800 to 6067200), with spacing of 100 m over 2000 m. The area has been surveyed 5 times.

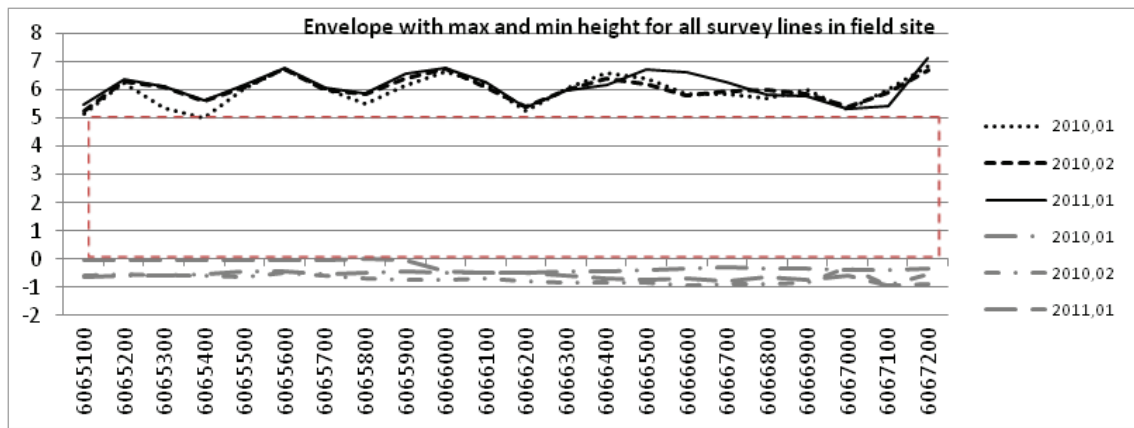
Figure 3.2. Cut-off of survey lines for volume calculation.

To use all survey data in a uniform way, an investigation of the total usable length of all the lines is made. By finding the lowest height of the lines in the dunes and the highest measured level of the surf zone, the cut-off level of the volume calculations can be found, see Figure 3.2. The so called minimum common area for volume calculation is determined to be from elevation 0 m to +5 m.

The range of length for the cross-sectional profiles is from -0.94 to 7.12 m. The considered envelope, describing the maximum common area includes measurements from 0 to 5 m. The variation in distance of the profiles is from 51.11 m to 117.22 m and indicates the disturbance of the groynes.

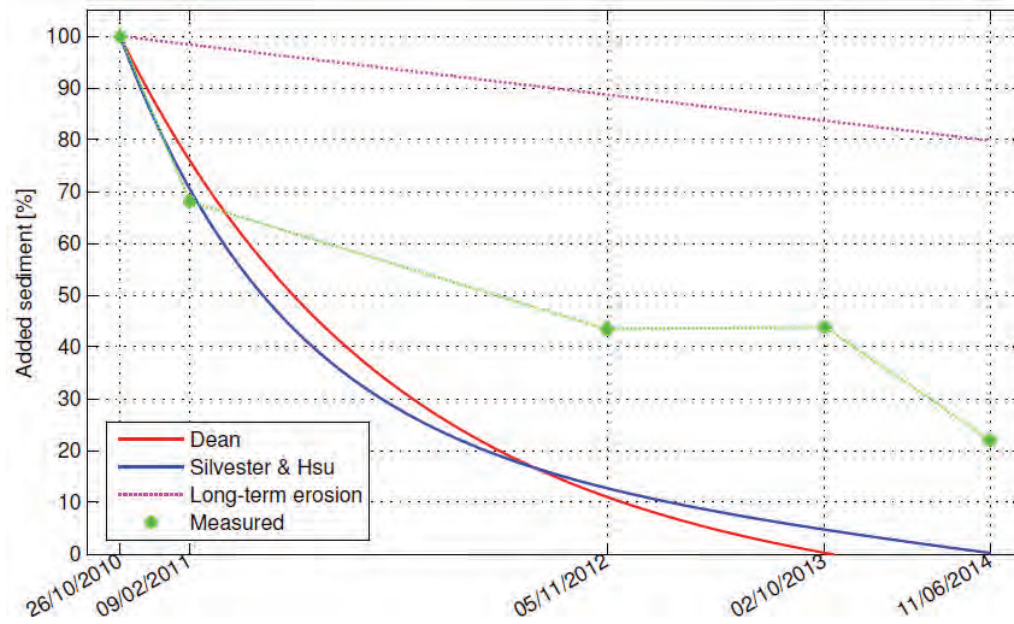
Figure 4.2. Volume decay.

For both predictions methods, the values are normalised and presented as percent values of the initial nourished quantity. The results are plotted in Figure 4.2, together with the measurements at the site.

As it can be seen, the measurements do not follow the theoretical curves. The nourishment decays quickly in the first interval. This happens because the deposited sediment gives the beach an unnatural profile. The period between the post-nourishment survey and the next one is a winter period, where sand migration is expected to be more active.

After the beach reaches the equilibrium profile the decay of the nourishment stops following the exponential decay predicted by the two methods. The February 2011 survey is executed after a storm period, whereas the subsequent surveys are executed during or after calmer weather seasons. After seasons of rough weather, more sand will lay further out in the profile, and after seasons of mild weather more sand will be brought to the beach area. Remember that the surveyed area is the beach; the area beyond the shoreline is not measured. This means that it is impossible to measure where the eroded sand goes.
