Ministry of Environment
and Food of Denmark
Coastal Authority

Beach Nourishment Effects

An Analysis of Beach Nourishment in Nørlev,
Denmark 2016

Maj 2020

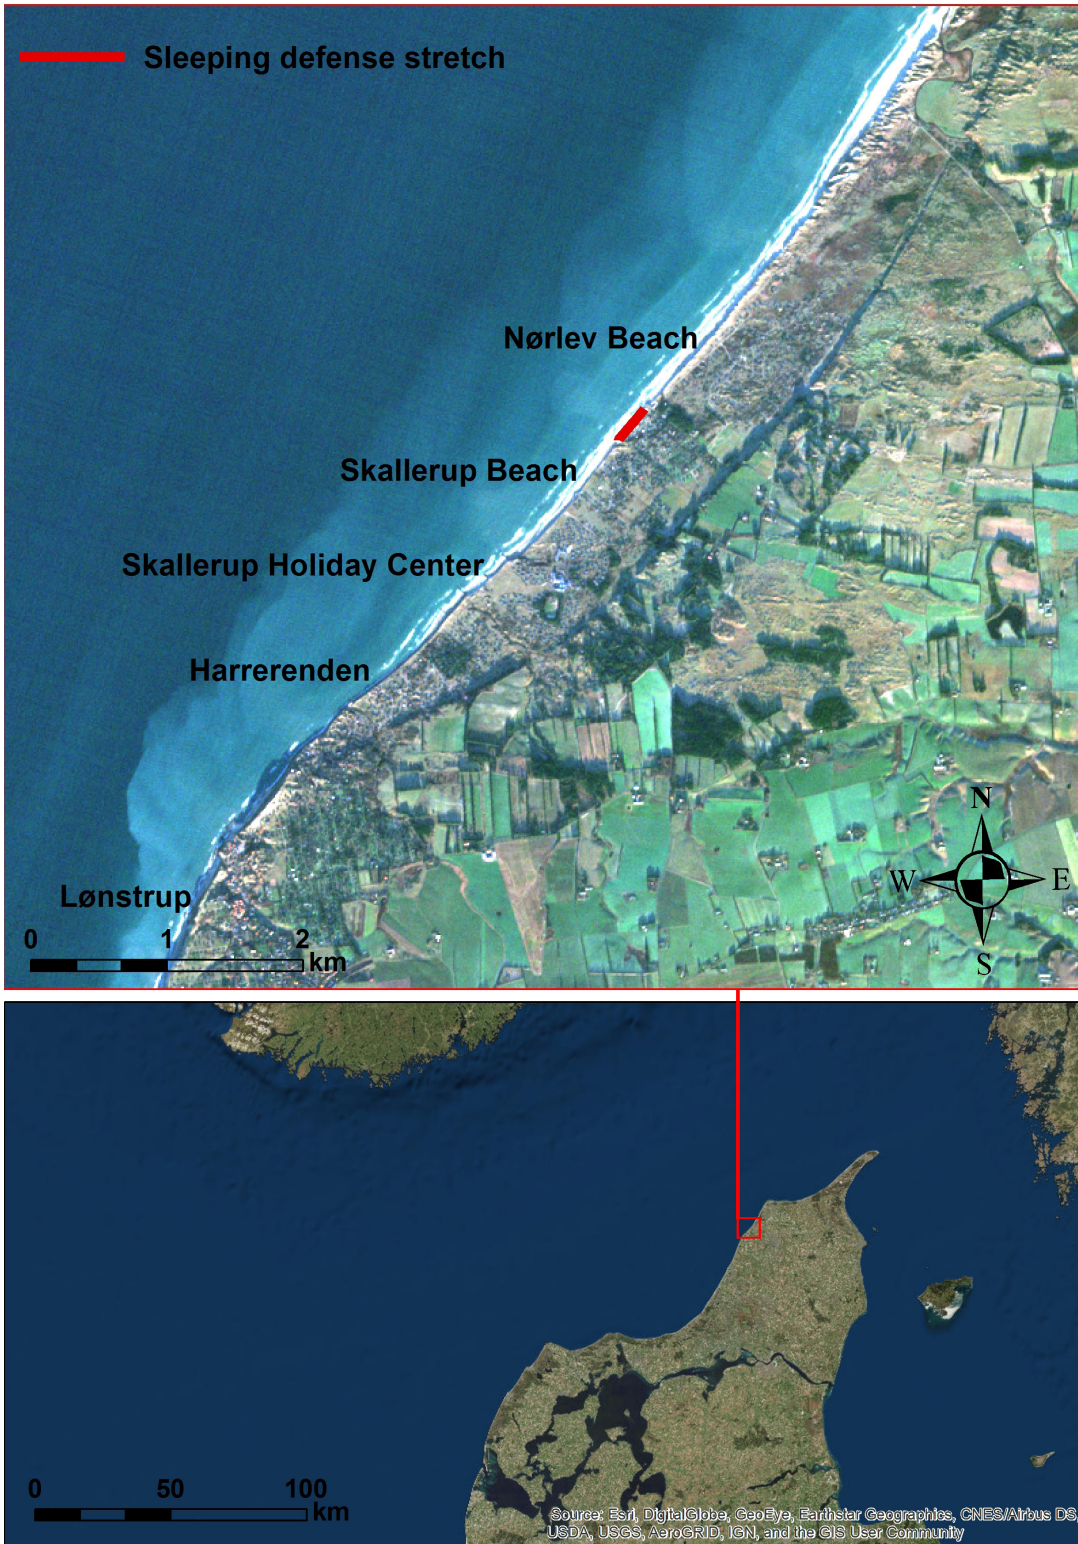
Figure 1.2: Overview of the stretch analyzed during the Nørlev beach analysis.

This report focuses on analyzing a beach nourishment in Northern Denmark at Nørlev Beach (Figure 1.2) from 2016. A beach nourishment of 12,475m³ covering a stretch of 340 m is placed in front of the dune and is intended to function as a sand buffer. Between the sand buffer and the existing dune a sleeping defense is constructed, as a rock revetment is installed as an extra safety measure. The sleeping defense is 265 m long. The coastal protection scheme was finalized in November 2016 and the performance of the nourishment and the coastal stretch have been monitored before and after in order to analyze the performance of the nourishment. The results from this analysis will be incorporated in future guidelines for beach nourishments.

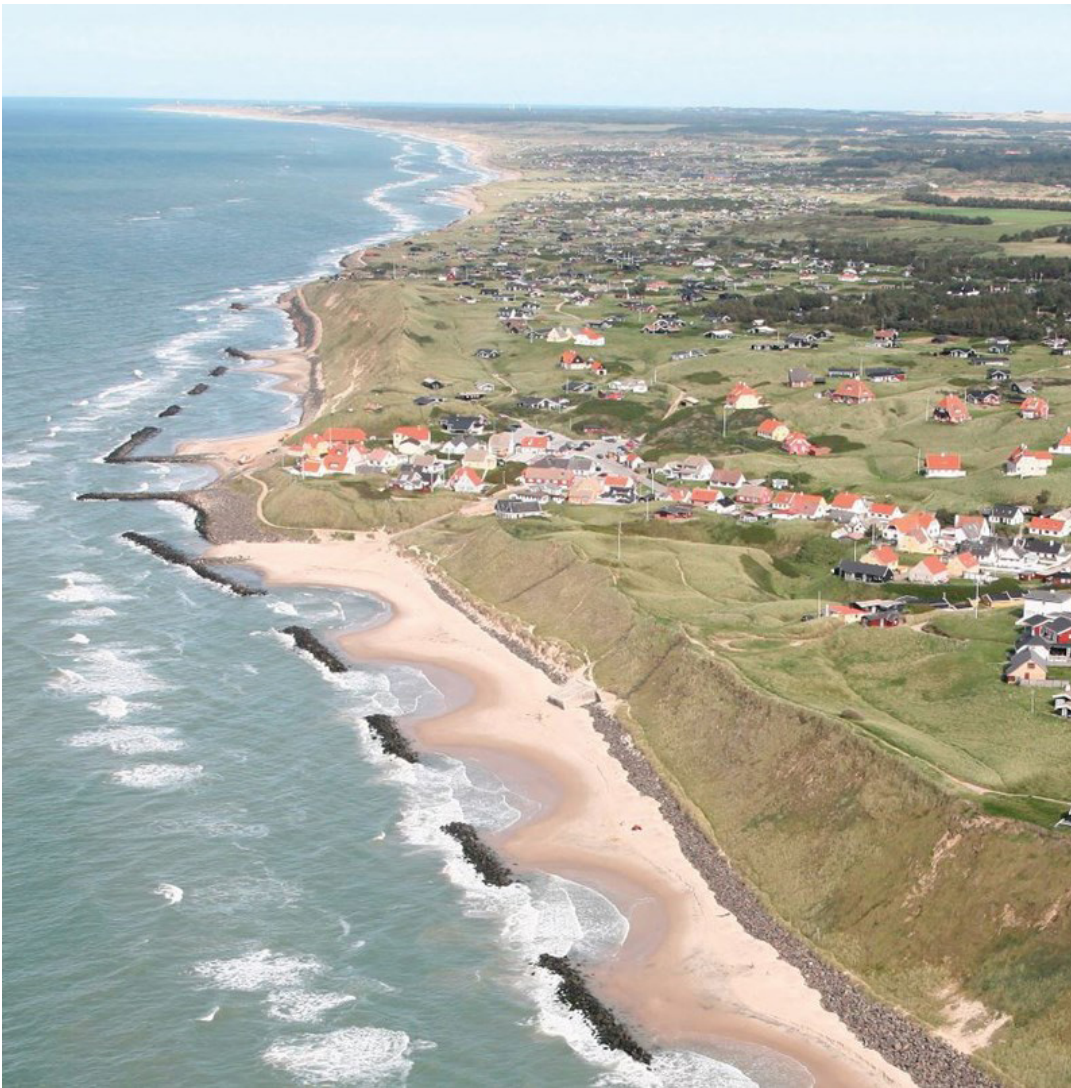
Figure 2.2: Photo of the seaside village of Lønstrup. Direction of sight is NE. Notice that Harerenden begins at the last breakwater.

The village of Lønstrup is located SW of the study stretch and is represented by West Coast survey Lines (WCL) 2020 and 2010. The town of Lønstrup is presented from aerial imagery in Figure 2.2. The moraine cliffs facing the ocean at Lønstrup are mostly covered with vegetation. This is a result of continuous beach nourishments in combination with construction of revetments and breakwaters. Coastal protection was initiated in 1982 as a result of a joint agreement between the local municipality and the Danish state in 1982 after a severe storm incident in 1981.

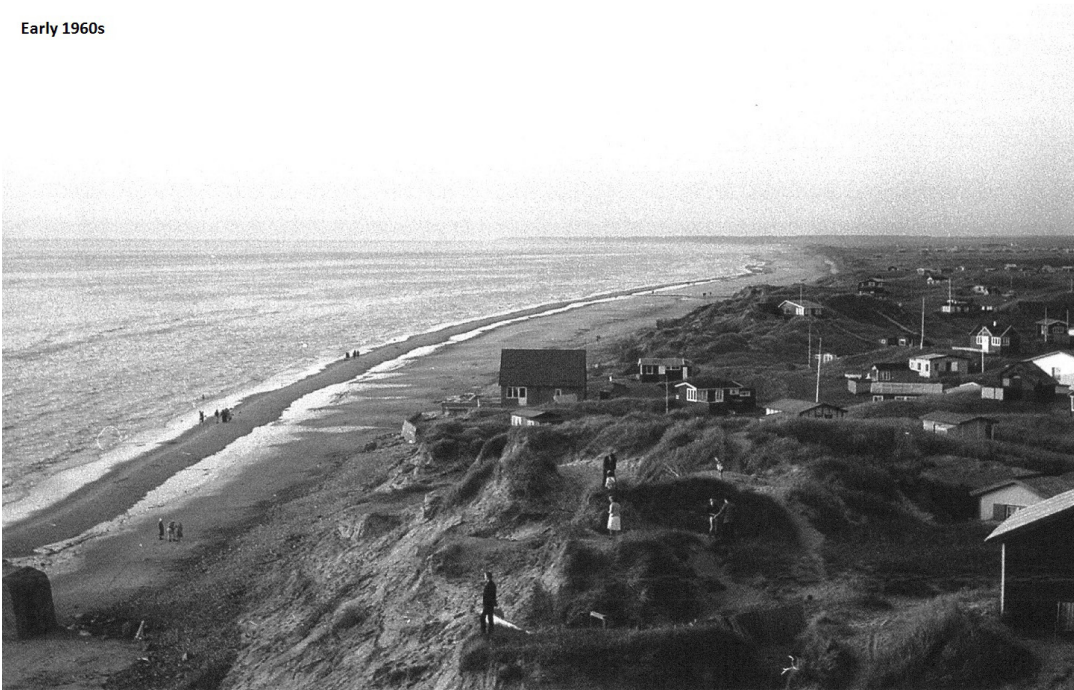
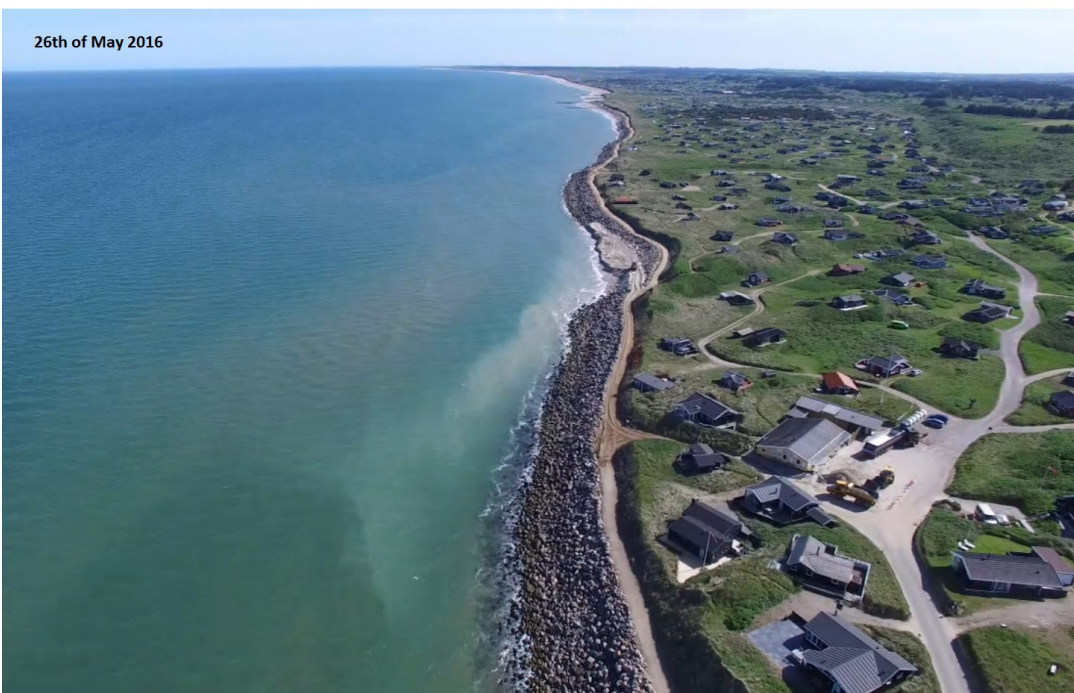
Figure 2.3: Top photo is taken around 1963 but the precise year is uncertain. The bunker seen in the bottom left corner of the old photograph is still visible today and is part of the northernmost wave breaker from Lønstrup. The bottom photo is taken by drone, just above the bunker's position in 2016.

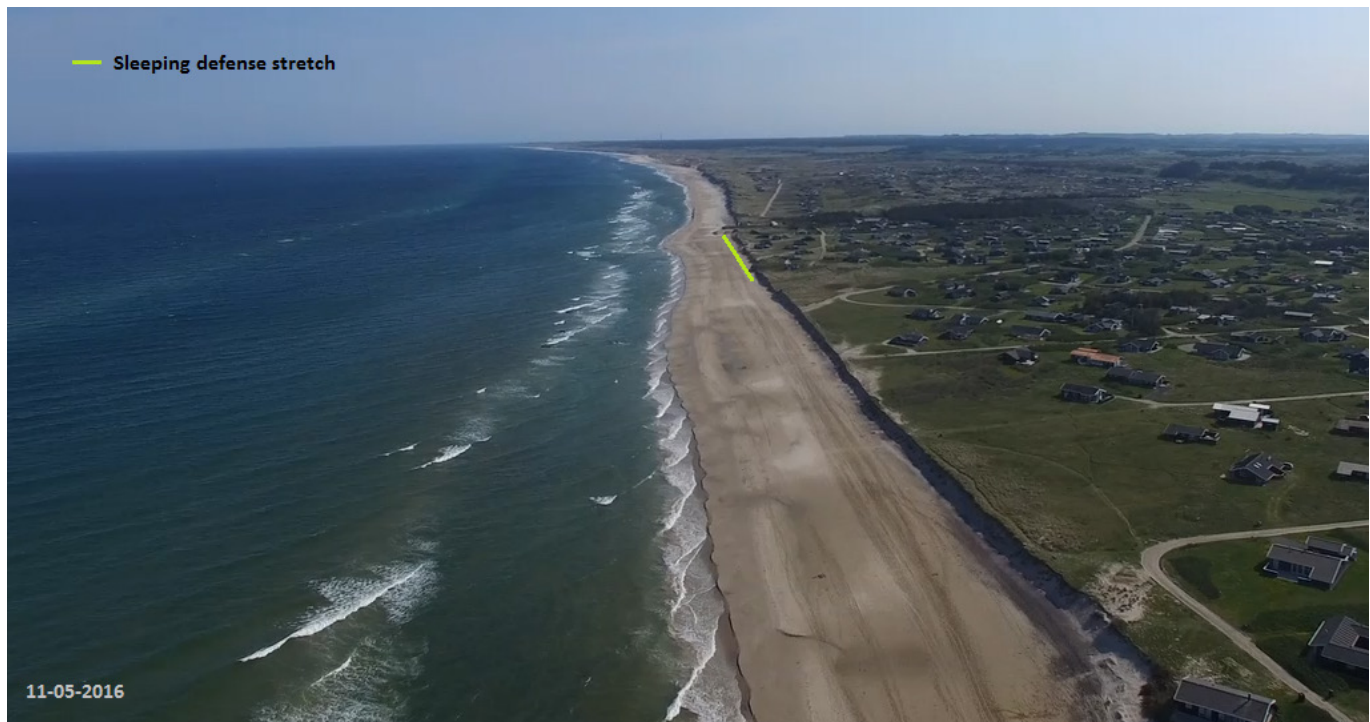
Figure 2.4: Photo is taken from “Morgenvvej” with direction of sight towards NE. The photo is from the 11th of May 2016 which is before the sleeping defense was installed. Nørlev Strandvej is located on the NE side of the sleeping defense stretch.

“Skallerup” is the area between WCL 1660 and 1650. On this stretch, beach scraping has been carried out over several years and four perpendicular groynes was built in the 1980s. When walking from Skallerup to the end of Nørlev beach a distinct change in coastline geology can be noticed. At Skallerup no dunes run parallel to the coast, instead the erosion has reached the inland sedimentary layers of uplifted marine foreland, which are demarcated by a sharply defined line of vegetation. This stretch was not protected by any structures in 1954, as seen from the imagery in appendix B, but during the 1970-ties revetments were built along Harerenden and following the leeside erosion, which was threatening a wastewater treatment plant at Skallerup as well as some houses close to the coastline. Four groynes were installed in 1985 and on multiple occasions they have been maintained by being moved inland in accordance with the profile retreat, by being shortened or by the adding of rocks, also, until recently, beach scraping has been performed between the groynes.

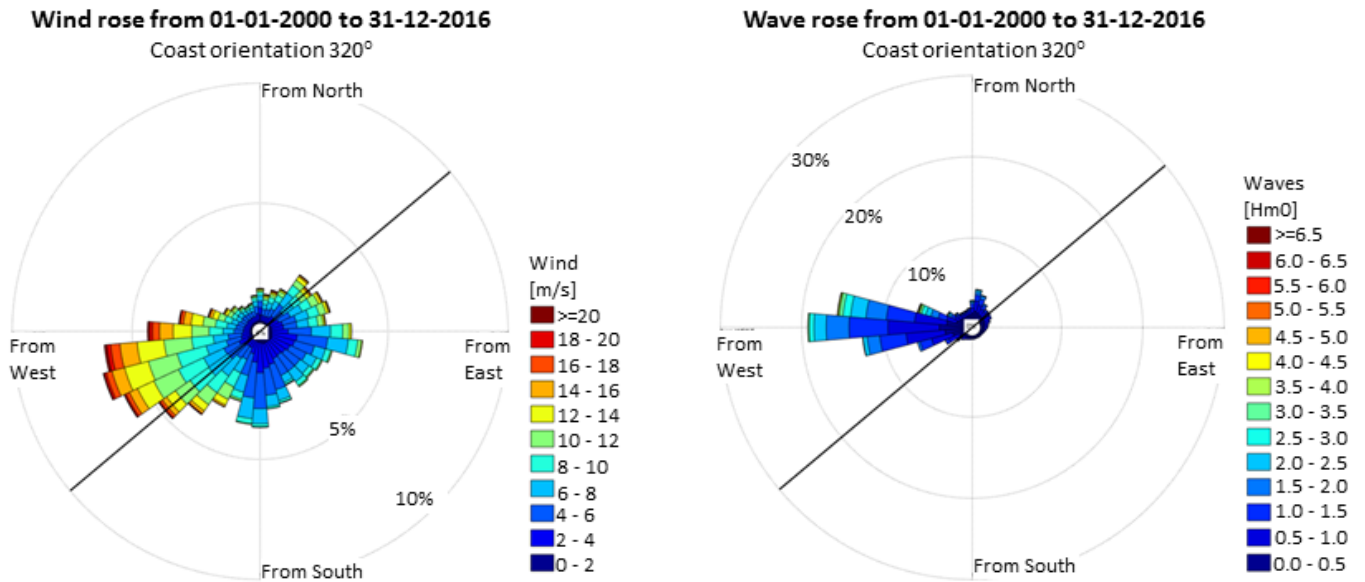
Figure 25: wave- and windroses for the period between 01-01-2000 and 31-12-2016. Wind is measured in m/s and data are from the physical wind gauge in Hirtshals with ID 1410. The Hm0 in the wave rose is measured in m and data are extracted from DHI Met ocean model on deep water outside Nørlev beach.

Nørlev Beach is located on a coastal stretch affected by the wind, waves and swell from the Atlantic Sea. The significant wave height is seen to reach levels >5 m with average periods of >6 seconds for storm cycles in the period of monitoring. The predominant wave directions are westerly, resulting in a net sediment transport towards NE. The dominant wind-direction is WSW.

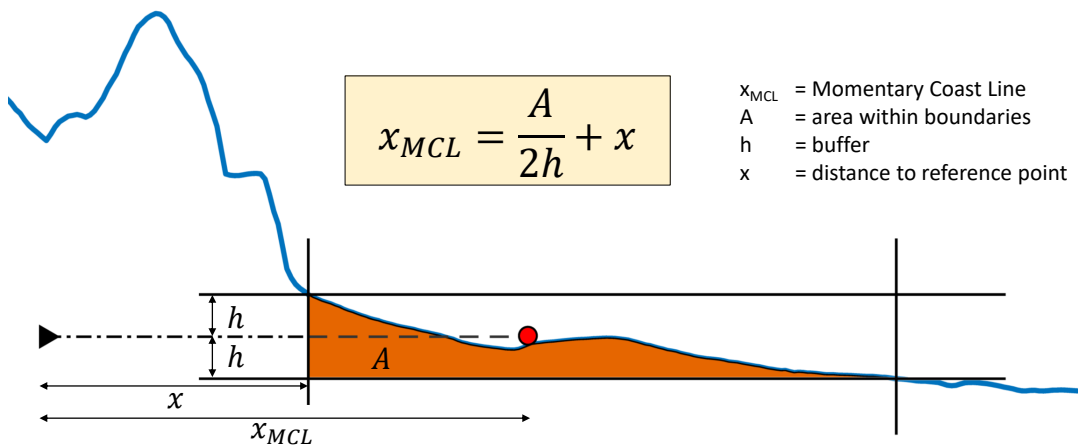
Figure 4.2: Example on how a Momentary coast line is found. The figure is based on the original from (Mulder, 2004) and has been presented in the BwN report from Skodbjerge, as well (Kystdirektoratet, et al., 2020).

The position is given as a length from an inland fix point on a predefined transect line and is found as depicted in Figure 4.2. The MCP is used to analyze the dynamic behavior of the coastline position. The

The MDP is found in the same way as the MCP, but obviously in the dune face. The MDP describes a position in the dune face and should represent a position well above any water level. The MDP will thus represent a position that will be mostly affected when the dune is undercut and the top of the dune slumps onto the beach or when aeolian processes add or remove sediment. The criteria make the MDP development comparable to vegetation line changes and comparison between the measures will serve to validate the results.

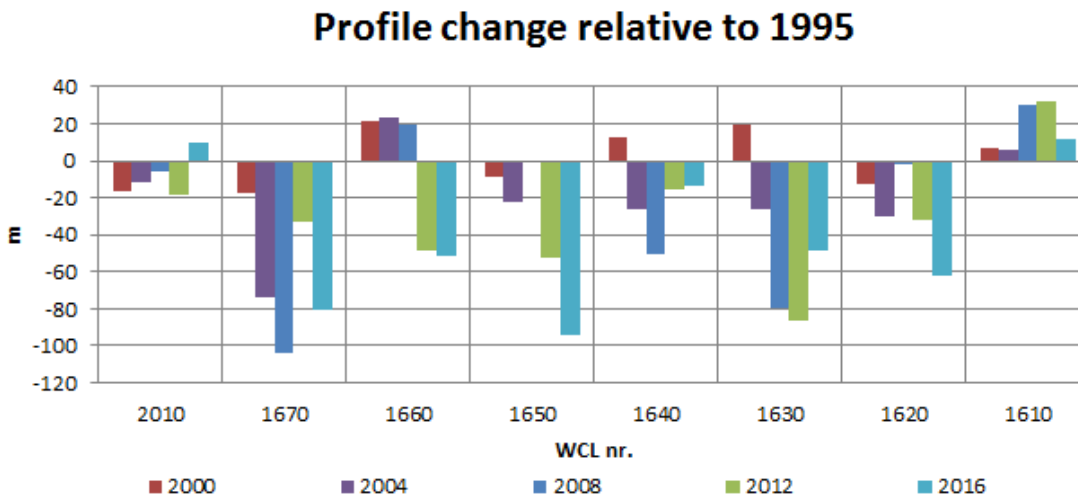
Figure 4.3: Profile movement relative to 1995. Profile defined from +4 to -8m

The profile developments between 1995 and 2016 are presented in Table 4.1 with their respective r^2 values. The r^2 value describes the linear regression trend calculated (profile movement) as described by the data. The profile development relative to the 1995 position is presented in Figure 4.3. As it is seen, it is not unusual that erosion/accretion rates vary over time, but some trends can be seen. These will now be described.

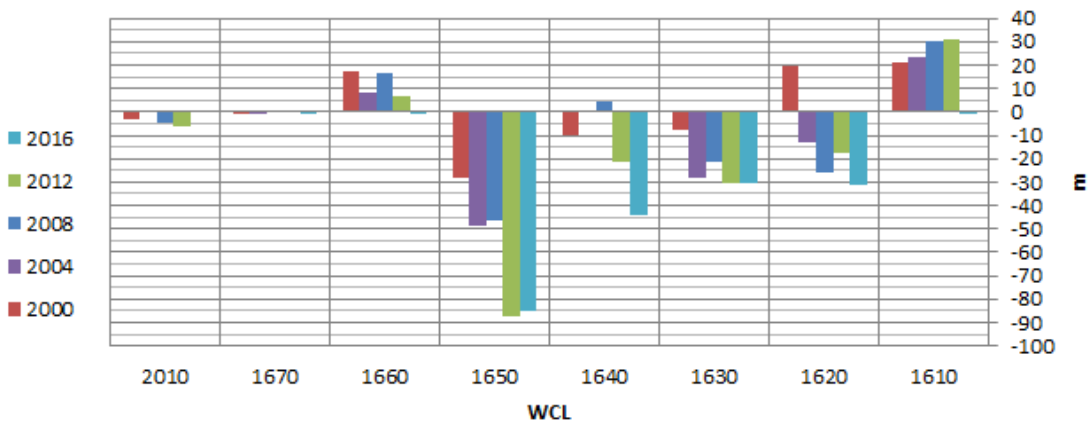
MCP position relative to 1995

Figure 4.6: The MCP (boundary layers are 0.5 m and -0.5 m) relative to 1995. MCP shows how the shoreline has retreated and advanced relative to the 1995 position.

To quantify the changes in beach and dunes the CSI parameters MDP MCP and beach width are used in the baseline study. Positional changes relative to 1995 is presented in Figure 4.6 (MCP) and Figure 4.7 (MDP) while the beach width is presented for all years in Figure 4.8 (beach width). In addition, the development of MDP has been quantified by linear regression and advance/retreat rates can be found in Table 4.2.

Both WCLs 2010 and 1670 appear stationary for both MCP and MDP, but this is to be expected as the coastline is defined by the revetments. The variations in line 2010 at Lønstrup can be attributed to the yearly beach nourishments conducted between breakwaters and revetment. Both MCP and MDP at line 1670 are close to the same position as in 1995, which corresponds with the primary retreat in the wet profile. The beach width at line 1670 is established to be +20 m for the measured years (except for 2012 when measurements are not available). The true width, as found from drone imagery, is 0.0 m of sandy beach on this stretch, but the beach width parameter, based on the horizontal distance between MDP and MCP, demonstrates its weakness here, as the MDP is measured above the revetment and the MCP is found in the revetment toe, therefore reflecting a section that is far too wide. Nevertheless, it is a measurement which can be used to sum up the total movement between MCP and MDP and can also be used to gain insight into local beach width differences between lines. Even at 1670 the beach width measure shows that there is little to no difference in beach width over time, and the existing differences are likely to be caused by variation in profile measurement quality. The beach width parameter also gives a very good indication of a general widening of the beach from WCL2010 towards WCL 1610 when looking at Figure 4.8.

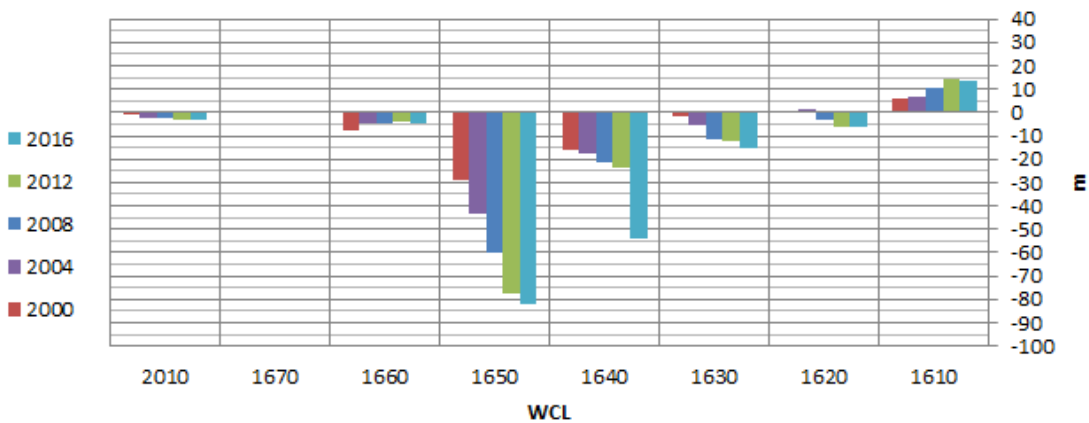
MDP position relative to 1995

Figure 4.7: The MDP (boundary layers are 4 m and 5 m) relative to 1995. MCP shows how the dune face position has moved in and out relative to the 1995 position.

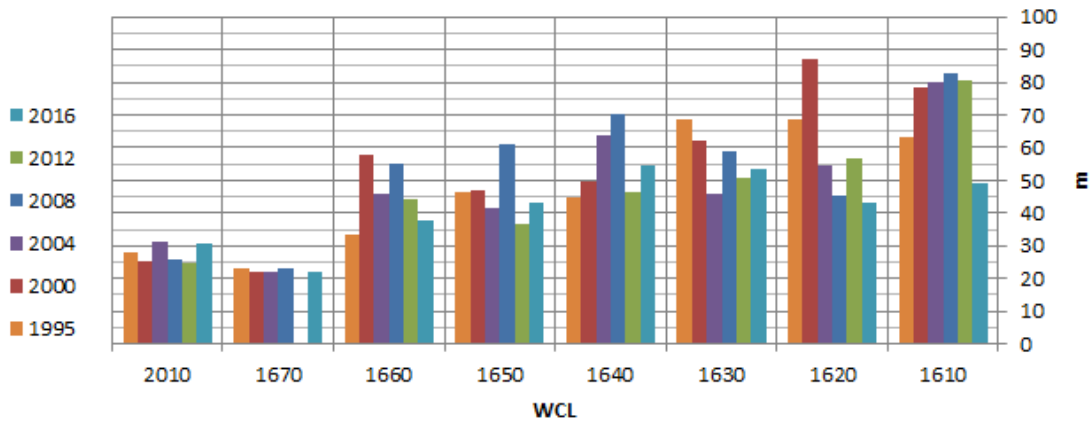
Beach width since 1995

Figure 4.8: Beach Width is determined as the horizontal length between MCP. The x-axis denotes the WCL number and the y-axis denotes the beach width in meters. The graph therefore shows the sum of MCP and MDP movement.

Line 1640 shows a 54 m retreat of the MDP and 43 m retreat in MCP between 1995 and 2016. The beach has generally widened since 1995, but as seen in Figure 4.8 the beach also narrows in between years. The MDP retreats with >15 m between 1995 and 2000 while the profile was found to advance during the same period. This is repeated between 2012 and 2016 when MDP retreats with more than 30 m, while the profile advances slightly during the same period. The retreat is most likely caused by leeside erosion from the groyne, and the fact that the closest groyne has been back-cut leading to increased dune retreat.

The beach width proved to be a good measure for the sum of MCP and MDP movements, and it underlines the dynamic behavior of the beach width fluctuations over time. The beach width variations are often found to be more than 10 m between years, which also represents the changing outline of the coast. The hydrodynamic conditions leading up to the single profile measurements will undoubtedly influence the results of MDP, MCP and profile development, and with four years between each measurement the temporal resolution is too high to form the basis for conclusions as to what drivers can affect the morphological changes, but some changes are likely to be inter-connected and the presence of longshore morphological phenomena such as beach and bar undulations are likely at the stretch at Nørlev. If this is the case, it may have affected the erosive patterns along the stretch. Undulation in both beach width and bar position has been studied earlier on other parts of the Danish west coast and their presence have been documented earlier by DCA both at the central part of the west coast as well as in the northern part of Jutland. Beach undulations were analyzed at Husby and Sdr. Holmslands Tange (Kasper Kaergaard, 2011) and there seemed to be a correlation between beach width and bar position demonstrated in a residual bathymetry. Breaker bars, rip current position and acute dune erosion where investigated in (Thorton et. al, 2007), and it showed a likely correlation between acute erosion and rip position. It is therefore likely that some erosional events can be linked to the morphological characteristics of the stretch.

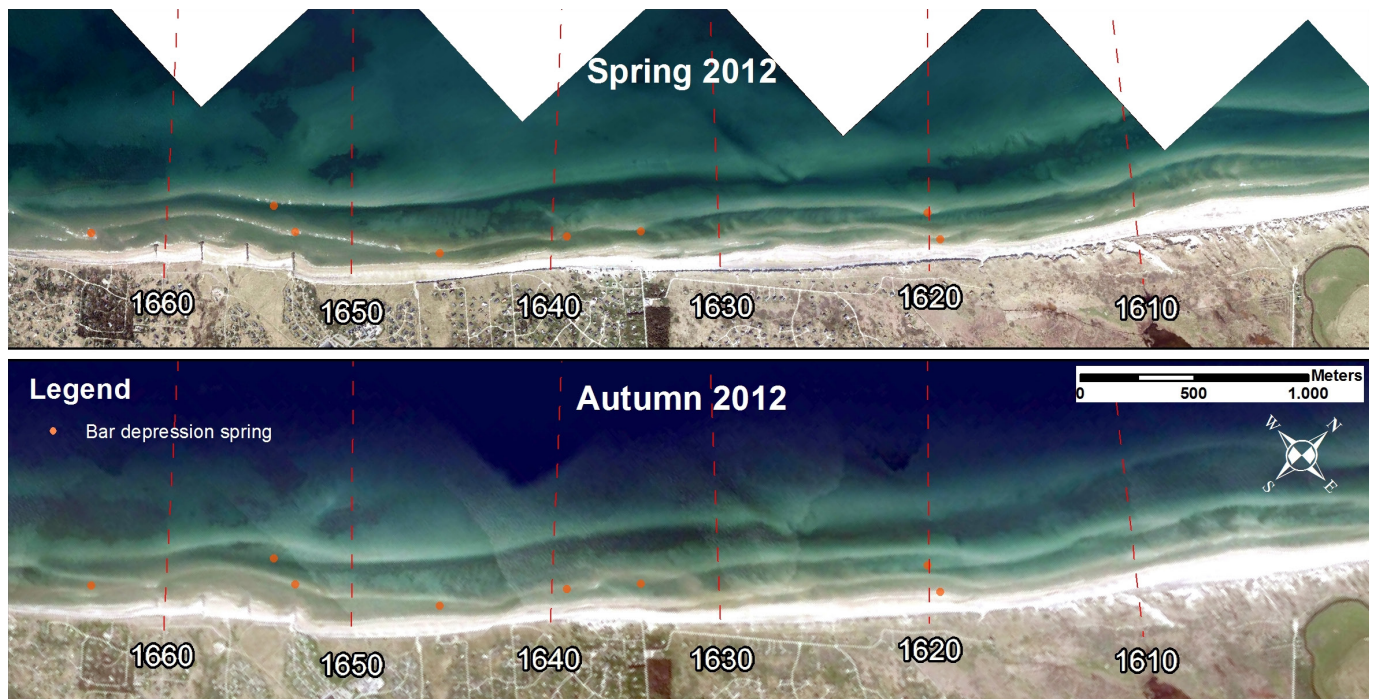
Figure 4.9: - Showing the bar development in 2012 from spring (1st and 2nd of May) to autumn (unknown date).

2012 - The beach varies in width along the full stretch, and seems wider than in 2010 at line 1650, but the dark coloring at the beach could indicate a lower beach in the SW part compared to the NW part. The 1st breaker bar is again seen to develop NW of line 1640, and the 2nd bar shows the same landward break as observed in other years. At line 1640 a rip or depression in the bar is visible and can be found from the profile envelope as well. A crescentic tip is observed at line 1620, which corresponds with a landward migration of the 2nd breaker seen in the profile envelope. The 3rd bar exists for the full stretch but shows irregularities and undulations. In contrast to other years orthophotos from both spring and autumn are

available. The exact days are unknown and it is therefore not possible to estimate a migration speed, but it is clear that the bar system migrates longshore as seen in Figure 4.9. Notice also that the rip in which line 1640 is measured in spring 2012 has moved NE in the autumn.

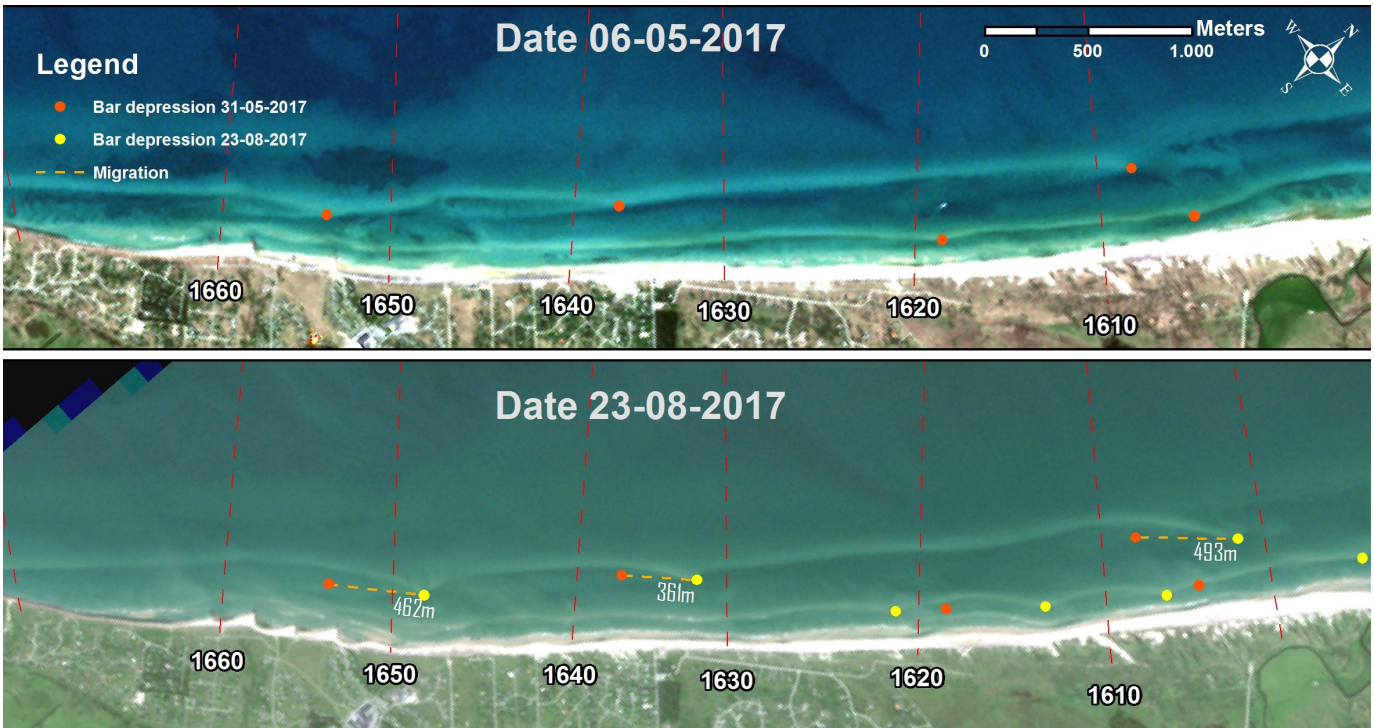
Figure 4.10: The migrations of the sand bars alongshore can be identified from satellite imagery from sentinel 2. Individual crest points have been visually selected and compared with the crest three and a half months later.

At the 5 km coastal stretch analyzed at Nørlev, one to three bars are present in the system. A near shore bar is not always present for the full stretch, but it often appears from the beach and outwards between line 1640 and 1630. The extra bar is a response to longshore sediment transport from SW towards NE, which is found to be very much influenced by the revetment and groynes at the upstream part of the coast analyzed. Undulations both in the beach width and in the bars, as well as development of crescentic bars are detected from the orthophotos between years. These shapes have been described to have locally erosive patterns at the embayment of mega cusps or embayments (Thorton et. all, 2007) and this is also expected to be the case in Nørlev - a more extensive study of the stretch is of course necessary to confirm the correlation, but the knowledge of differentiated behavior of the Nørlev breaker bars and beach is likely to have influenced the erosional patterns.

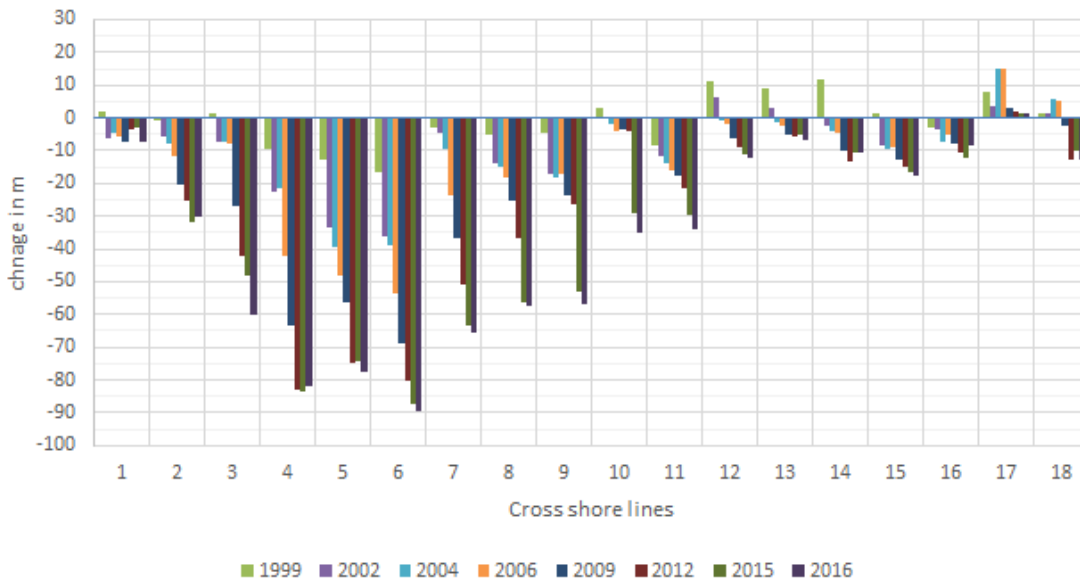
Change in vegetationline since 1995

Figure 4.12: The relative location of the vegetation line relative to the 1995 position.

A possible method for analysis would be estimating longshore variations vegetation line advance/retreat as this can be quantified in higher temporal resolution than the MDP due to available orthophotos. The boundary between vegetation and active dune face first needs to be drawn for all available years. This process was manual and performed in ArcMap with a zoom of [2000:1]. The quantifications will serve as rough approximations since slight drawing errors can result in inaccuracies of several meters. After drawing the vegetation lines, the planimetric changes are computed along cross shore lines (CSL). The position of the CSLs are presented in Figure 4.11 together with the sectional separation of the stretch, and the position of the WCL. The CSLs are placed with a 100 m spacing, and are set perpendicularly on an inland boundary line. Workflow and table with retreat rates (m/y) can be found in appendix A, while the retreat given in meters relative to 1995 can be seen in Figure 4.12.

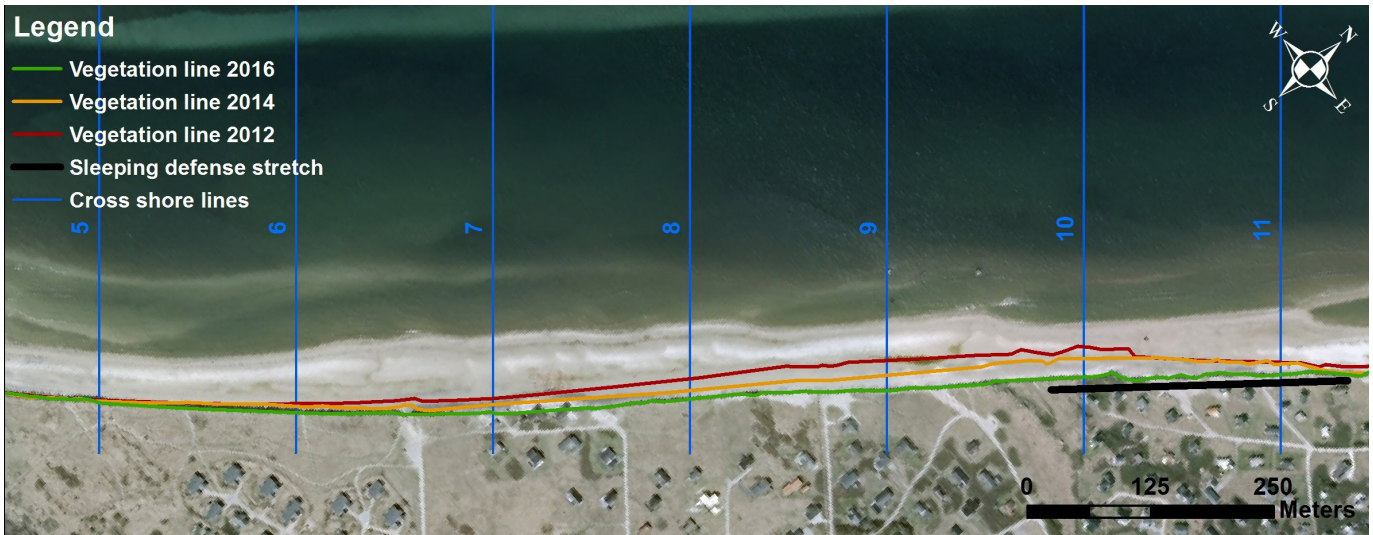
Figure 413: The vegetation lines from 2012, 2014 and 2016 are included to illustrate the longshore movement of erosional hotspots. Erosional peak between 2012 and 2014 is found between CSL 9 and 8. This changes between 2014 and 2016 when peak erosion is found at CSL 10. Notice also the stable vegetation lines from CSL 5 to 6 in this period and the longshore increase in retreat.

The shortenings of groynes 3 and 4 between 2013 and 2014 may have stabilized the retreat at CSL 4 to 6. But the longshore differentiated erosion rates between CSL 7 and 11 are also likely to be the result of headland equalization due to the extensive erosion at CSL 4 to 7 between 2004 and 2012. The profile envelope from WCL 1640 from 2012 and 2016 (Figure 4.14) indicates a larger breaker bar at -3 m in 2012, whereas 2016 indicates two more well defined bars. The 2012 orthophoto in Appendix B reveals that a rip is present in the inner bar system, and that line 1640 most probably has been measured exactly in this depression. The 2014 orthophoto revealed a narrowing beach, as well as depression and landward undulation of the 2nd breaker bar between WCL 1650 and 1640. It is not unlikely that these morphological characteristics have contributed to the increase in retreat of the vegetation lines in the period between 2012 and 2016.

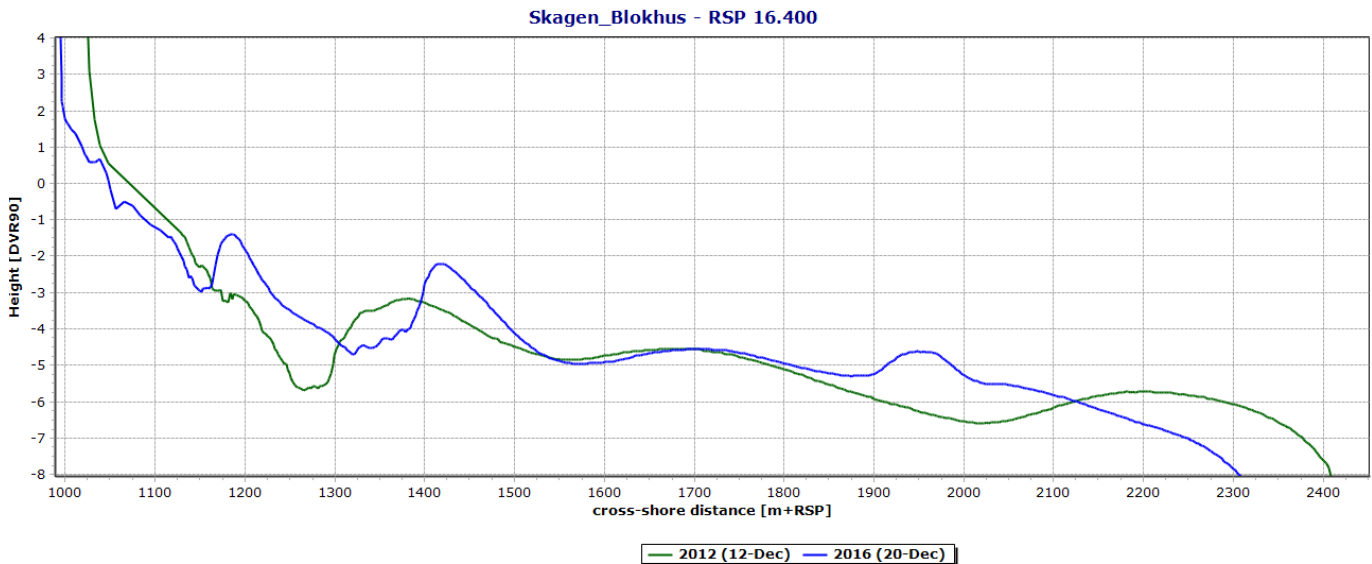
Figure 414: The difference between the profile measurements in 2012 and 2016 at line 1640. Notice the development of two bars in comparison with 2012.

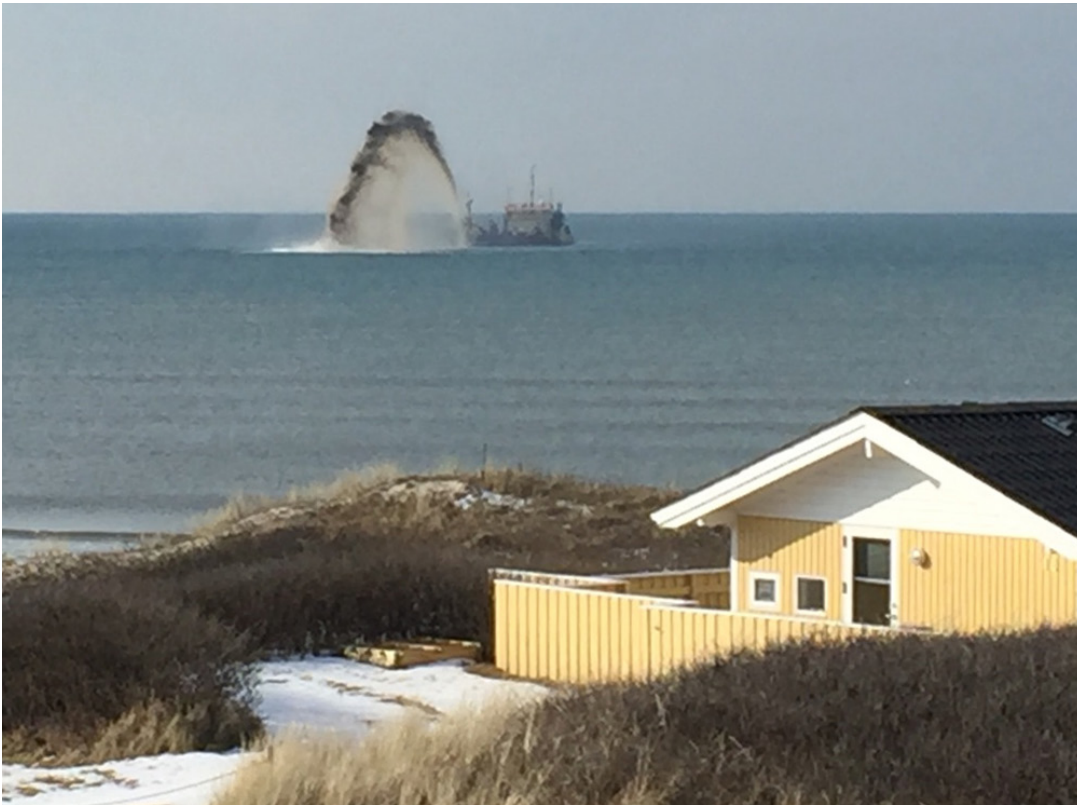
Figure 5.1: Shoreface nourishment on the shoreface outside of Skallerup Klit. No precise location of the nourishment exist.

Compensating nourishment volume was calculated at 18,000 m³ /year based on an chronic erosion rate of 3.8 m/y. The compensating nourishment can be placed anywhere in the active coastal profile. The landowners chose to add the sand just outside the 3rd breaker bar near the groynes at Nørlev.

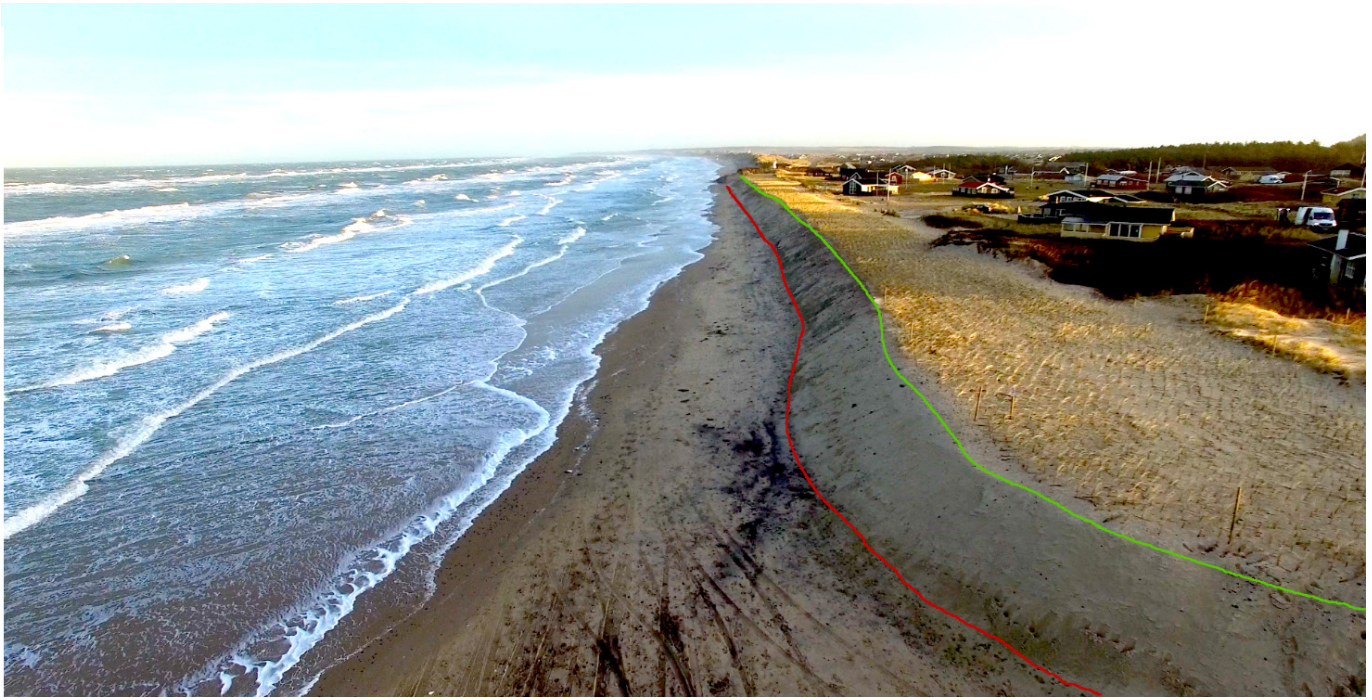
Figure 5.2 - Same as Figure 4.1, but here direction of sight is SW. The installation of the nourishment was finished on the 21-11-2016, and was measured on the 22-11-2016.

The beach nourishment was deposited by dumpers, while bulldozers were used to distribute the sediment evenly along the revetment. This method resulted in a lower compaction of the sand compared to pumping via a pipeline. The finished nourishment with underlying revetment or sleeping defense is pictured in Figure 5.2 under strong wind conditions (-10 m/s). In addition to the nourishment, marron grass was planted on the nourishment top to reduce sand drift. The averaged contours for the nourishment was 0.98 m for the nourishment toe, the crest was 3.77 m and the inland top of the nourishment was 4.53 m. Average heights were measured on 4-11-2016 when the nourishment was completed, but it was not reported to be finished until the 21-11-2016. An inspection of the finished construction was made on the 22-11-2016 supported by a drone flight.

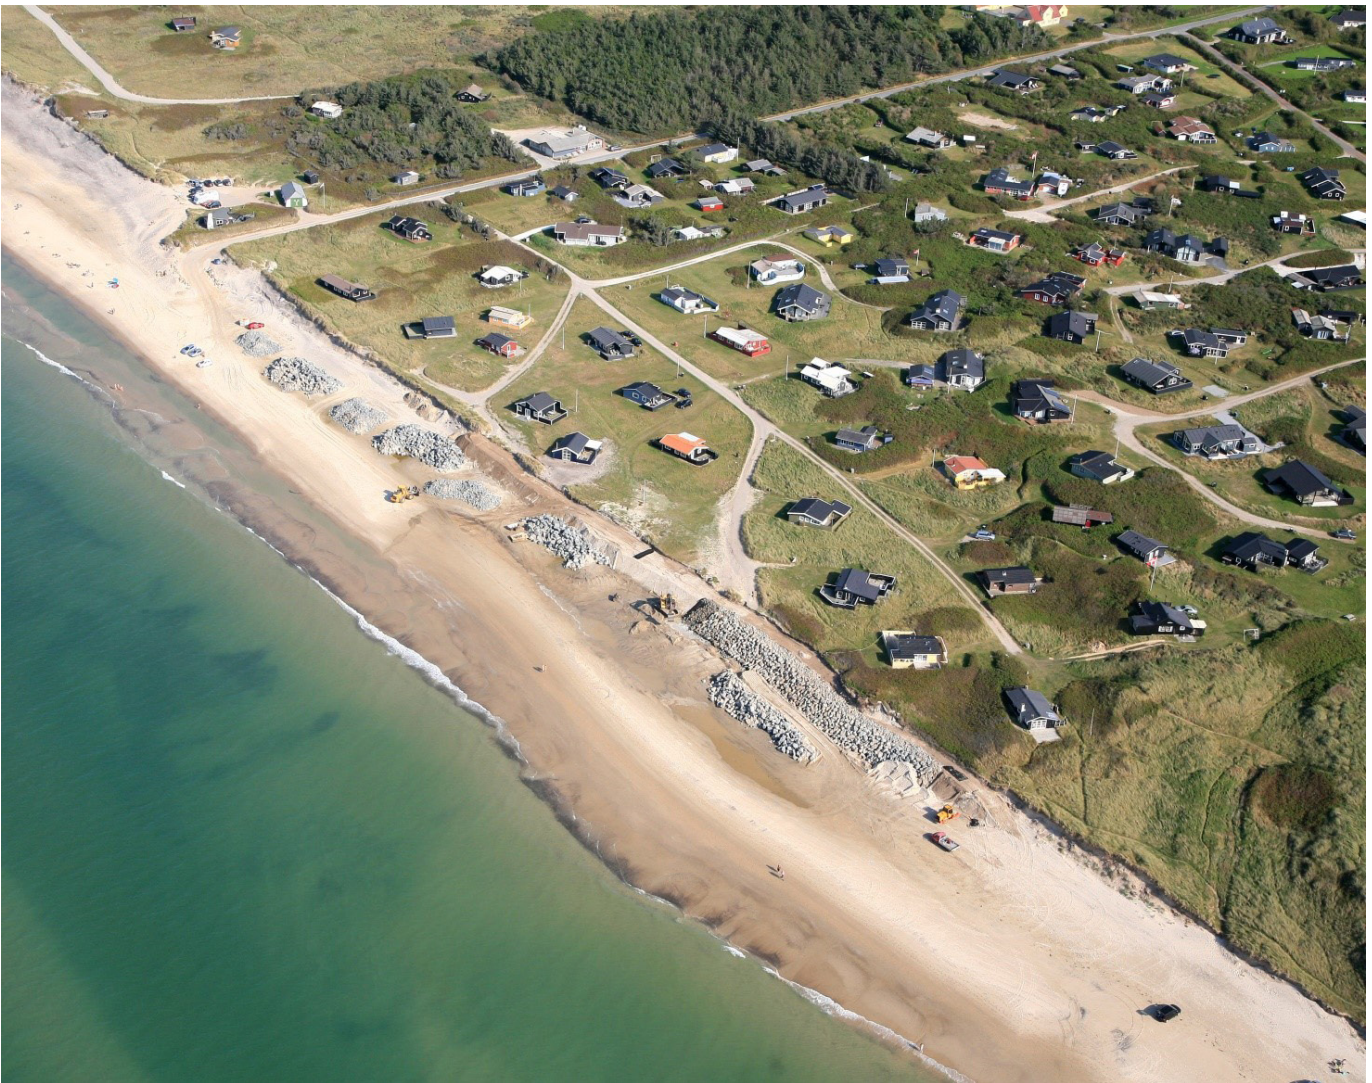
Figure 5.3: Construction of the revetment. Photo is taken on the 13th of September 2016. Notice how additional sediment has been placed behind the revetment.

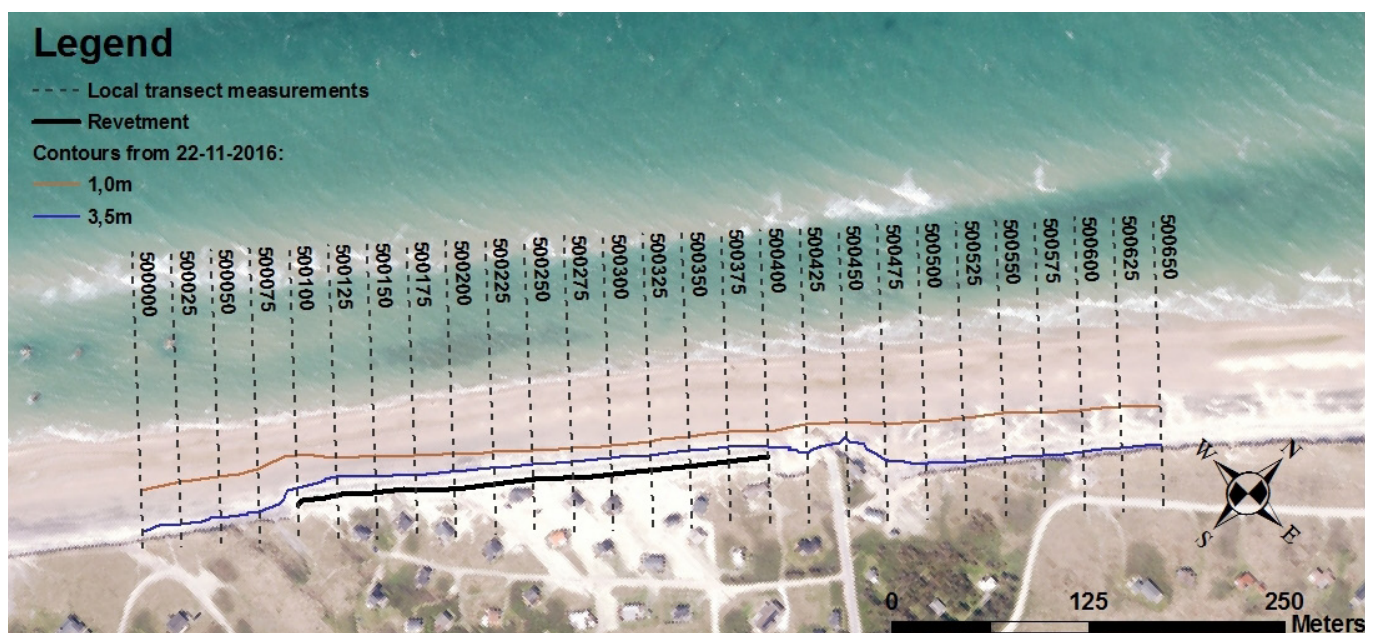
Figure 5.4: Presentation of the measured transect lines together with revetment stretch and contours 1 m and 3.5 m from the 22-11-2016 measurement. Underlying photo is from 2017.

The accuracy of the data is the same as that of the WCLs as they are measured using RTK dGPS and total station. Since point measurements from measurement campaigns are never perfectly aligned with a predefined transect line, alignment of points to transect lines have been done manually before triangulations or interpolation.

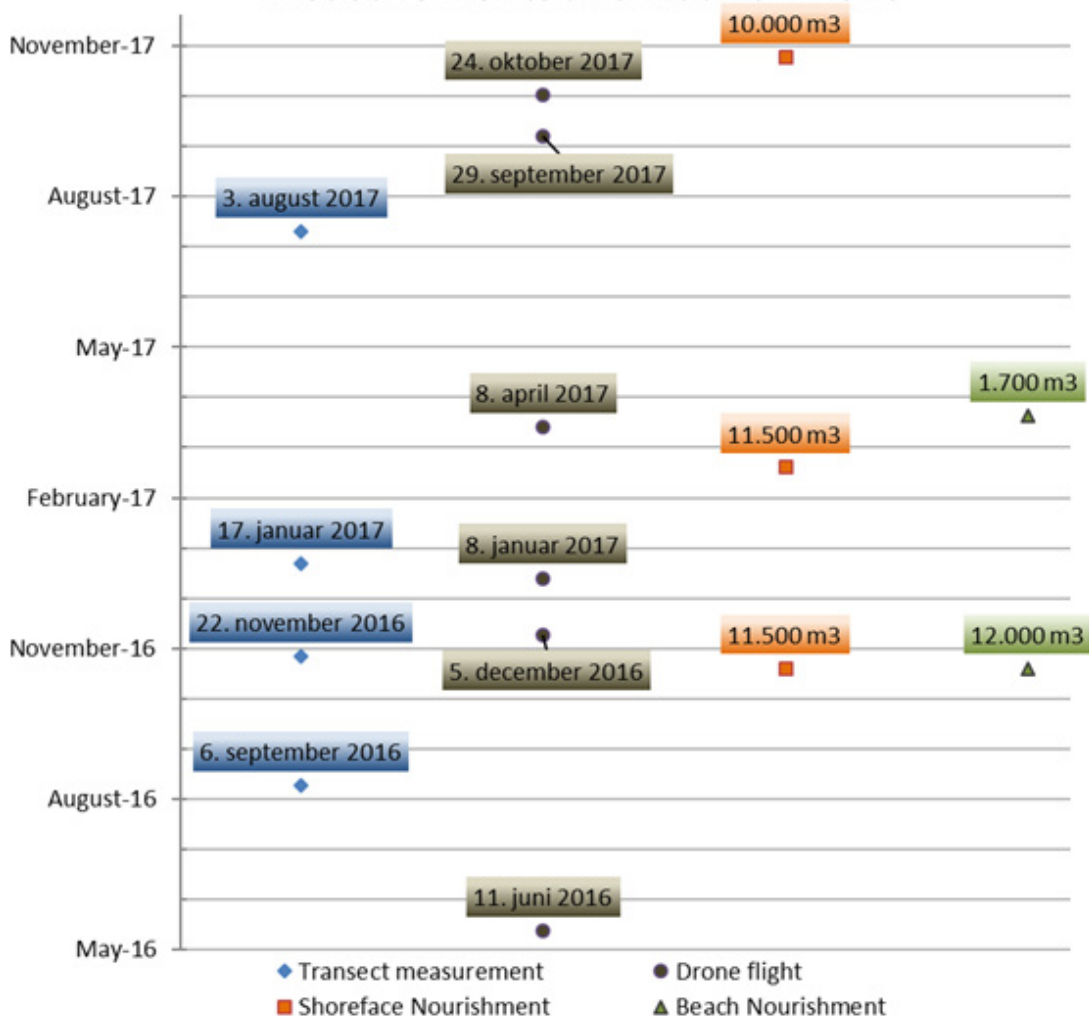
Timeline measurements and nourishment

Figure 5.5: The figure serves to give an overview and insight into the timeline over significant events during the period of monitoring. The precise dates of nourishments are unclear but the months and year in which they have been made are used instead.
