Ministry of Environment
and Food of Denmark
Coastal Authority

Beach Nourishment Effects

An Analysis of Beach Nourishment in Nørlev,
Denmark 2016

Maj 2020

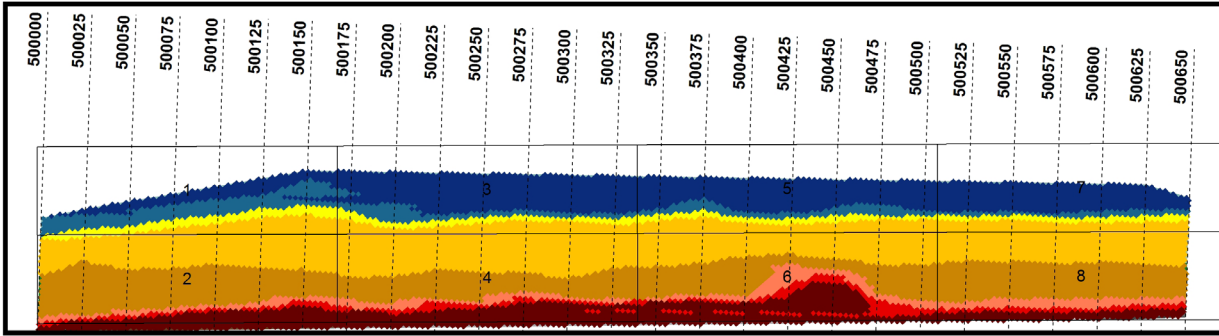
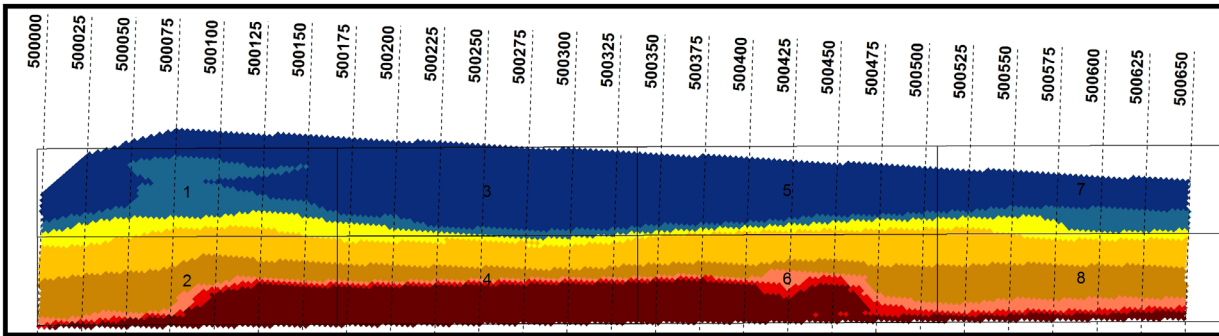
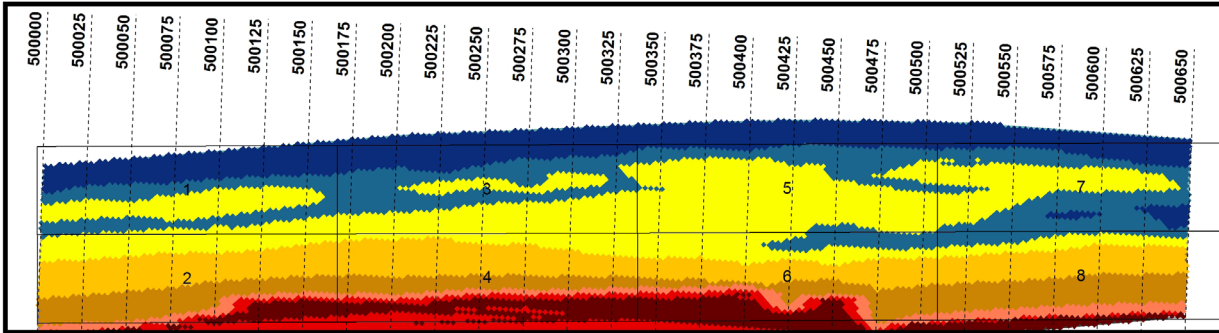
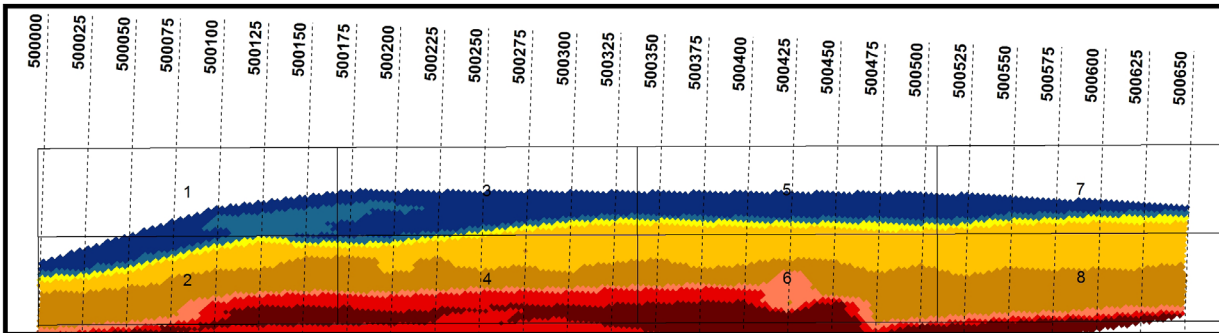
Figure 61: Location of local survey lines and boxes 1-8. The different colors show the different intervals such as the tidal range of 0.3 m (blue) and the MDP levels between 3.5 m and 3.0 m (red/brown).

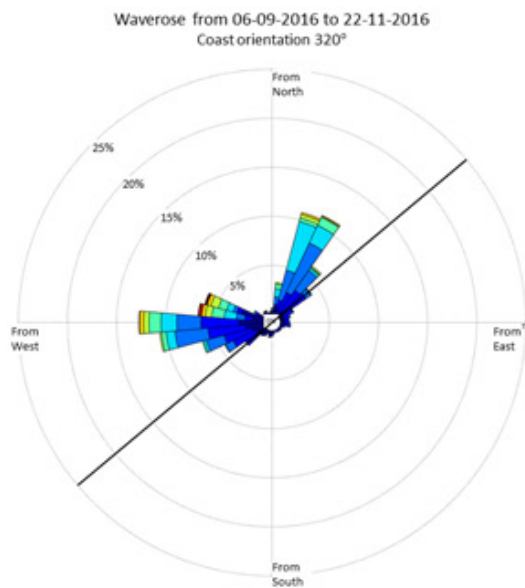
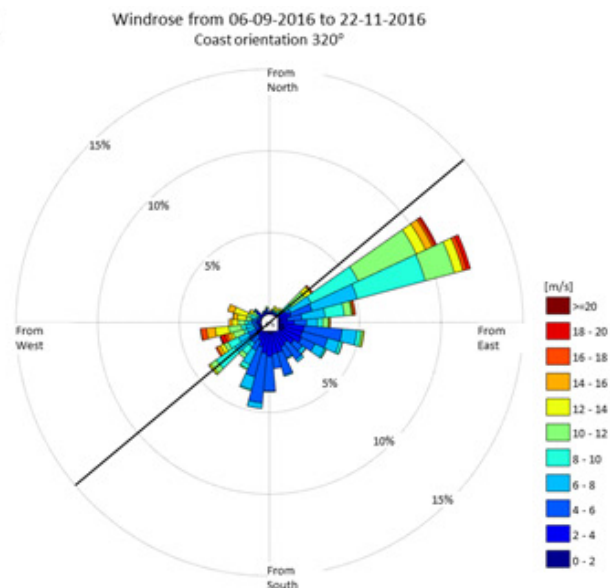
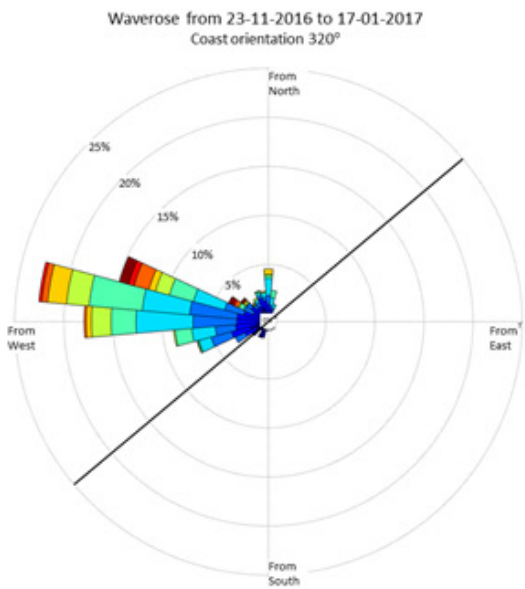
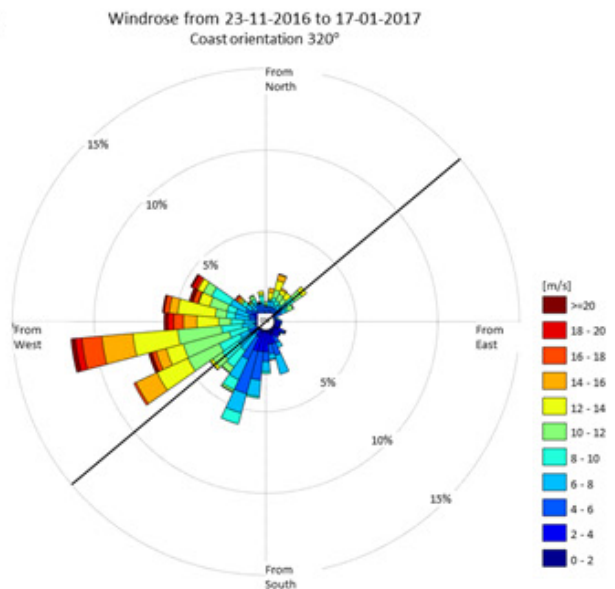
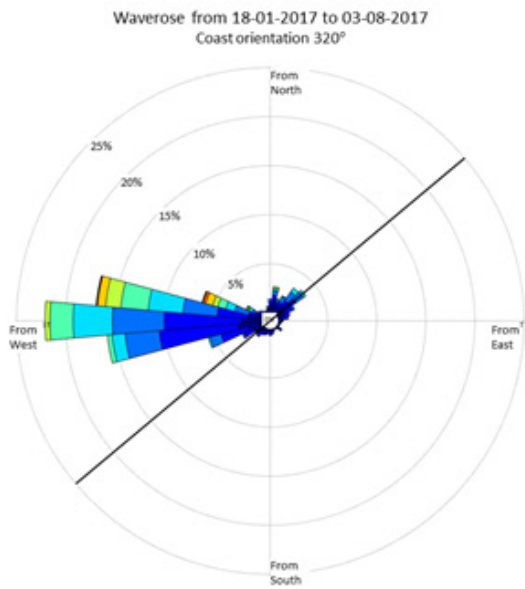
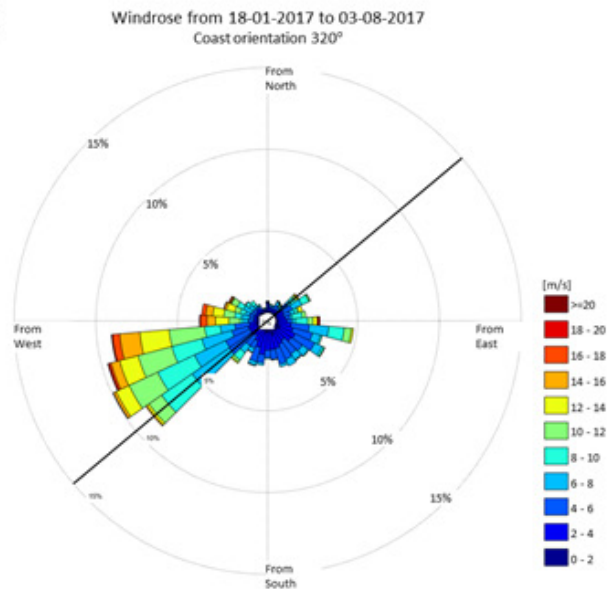
Figure 6.2 Wind roses (left) and waveroses (right) between local surveys.

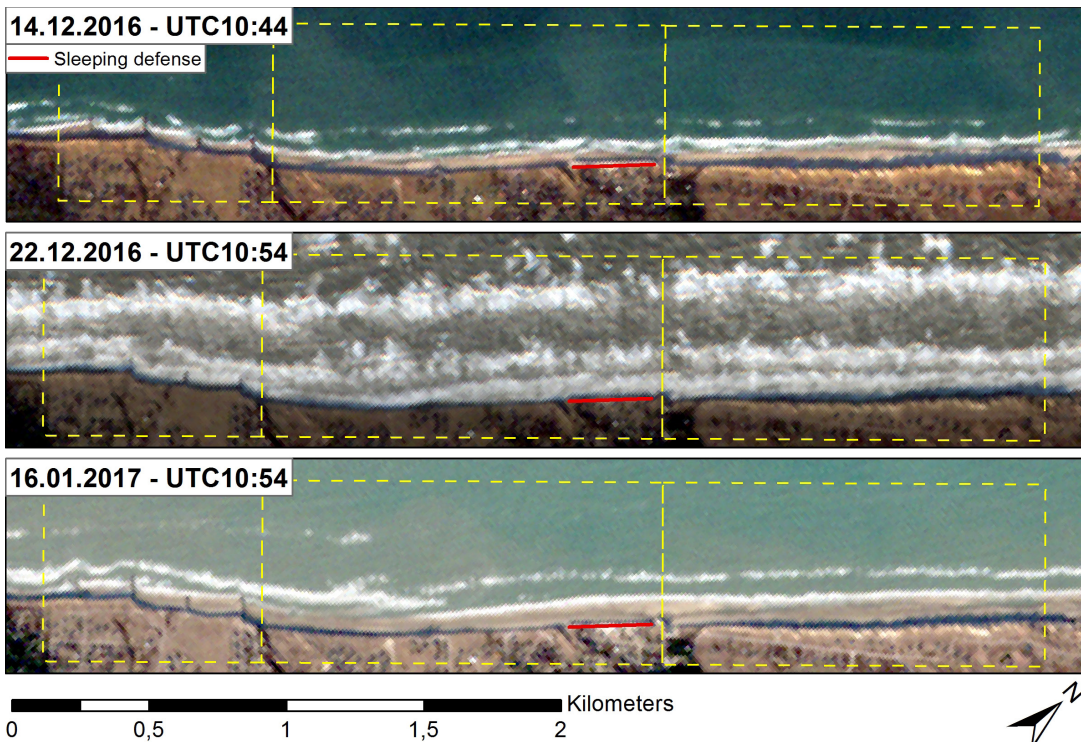
Figure 6.4: Satellite imagery collected from the sentinel 2 satellite in 10X10 m grids. The dates in upper left corner is in UTC times meaning that the local time is -1hour. Water levels: 14.12.2016 - local time 09:40 was -33cm, 22.12.2016 - local time 09:54 was +33, 16.01.2017 - local time 09:54 was -23cm.

The sand buffer was confirmed to have been redistributed already on the 8th of January, which corresponds well with the retreat of the dune face in boxes 2, 4 and 6 (Figure 6.1) and this is probably a result of the storm in late December 2016. The non-existing beach in front of the revetment, shown in the drone images from the 08-01-2017, does not correspond to the shape seen in Figure 6.1, as a seaward advance of the 0.0 m contour is identified with respect to the position on the 22-11-2016. Since the water level maximum is +5 cm in the drone image from the 08-01-2017 it is possible that the beach is submerged in the images, but a bar or berm can be identified in the shape from 17-01-2017 in Figure 6.1 which corresponds with the 1st breaker seen from the drone image. As a storm passed between the 11th and 13th of January with waves predominantly from W it is likely that the undulation in the beach seen in the SW end of the revetment stretch from 8th of January 2017 has migrated towards the NE and to the front of the revetment. The period between 13th and 17th of January showed average HmO of 1 m and an averaged 325° wave direction which is close to the coast normal. Buffer sediment redistributed across shore is therefore likely to have migrated back to the beach between the 13th of January and the 17th of January 2017.

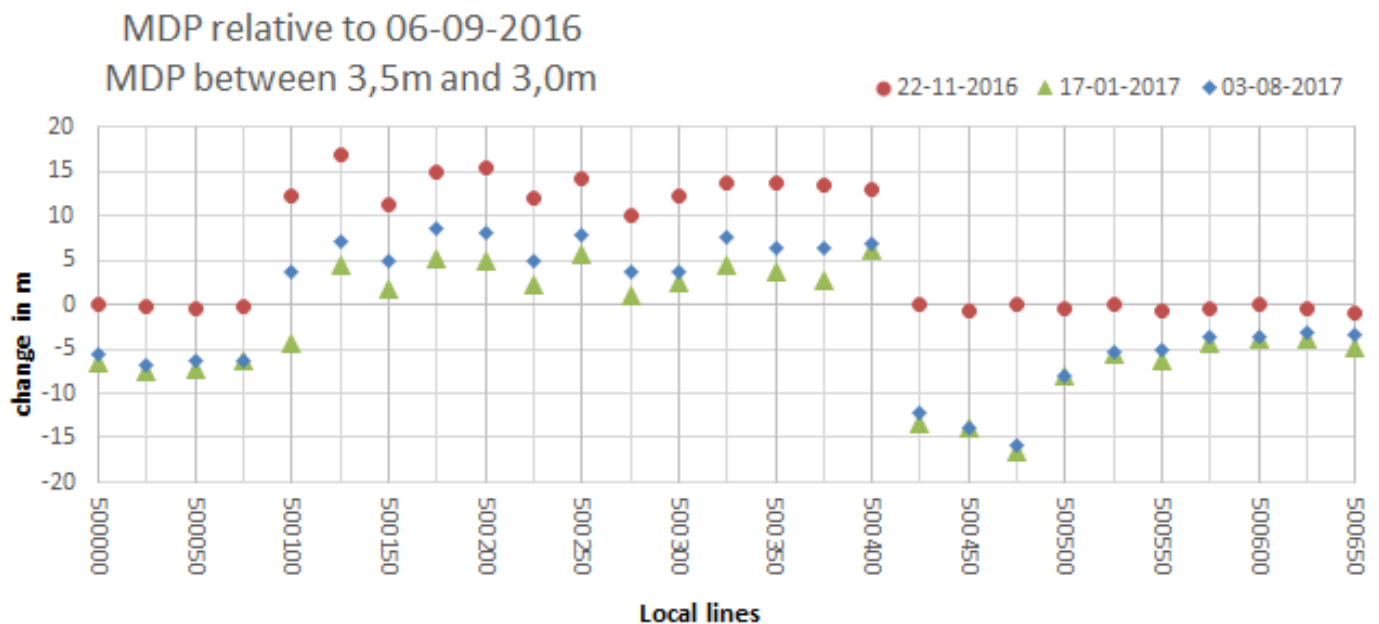
Figure 6.5 - MDP has been visualized by idealizing lines between the MDP points of each period. The revetment is not to scale, and merely illustrates the transect extent. The 17-01-2017 line from 500125 to 500400 illustrates the revetment position to scale.

The first measurement after construction of the sleeping defense was on 22-11-2016 and it therefore reflects the maximum extent of the sand buffer, which is the advance seen for lines 500100 to 500400. The advance of the sand buffer is irregular and ranging between 16 m and 10 m which is explained by the slight fluctuation of the dune face before the coastal protection was installed. The difference in advance is caused by the straightening of the sand buffer which can be seen on the drone imagery from December 5th 2016. The exposed position (15 m) of the sand buffer is clearly to be seen.

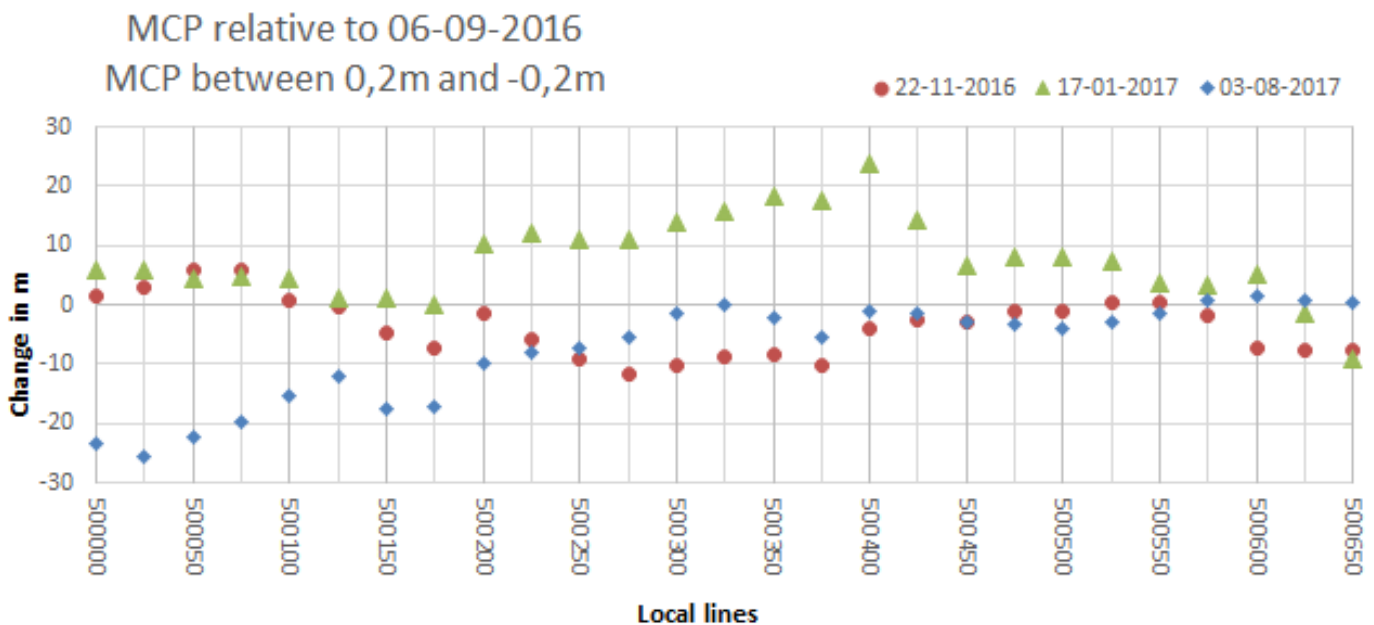
Figure 6.6: The momentary coastline has been found for every transect measurement in MorphAn. The position for each line was given in meters from a defined fix point inland. The purple box represents the revetment and is not to scale. It merely illustrates the transect extent.

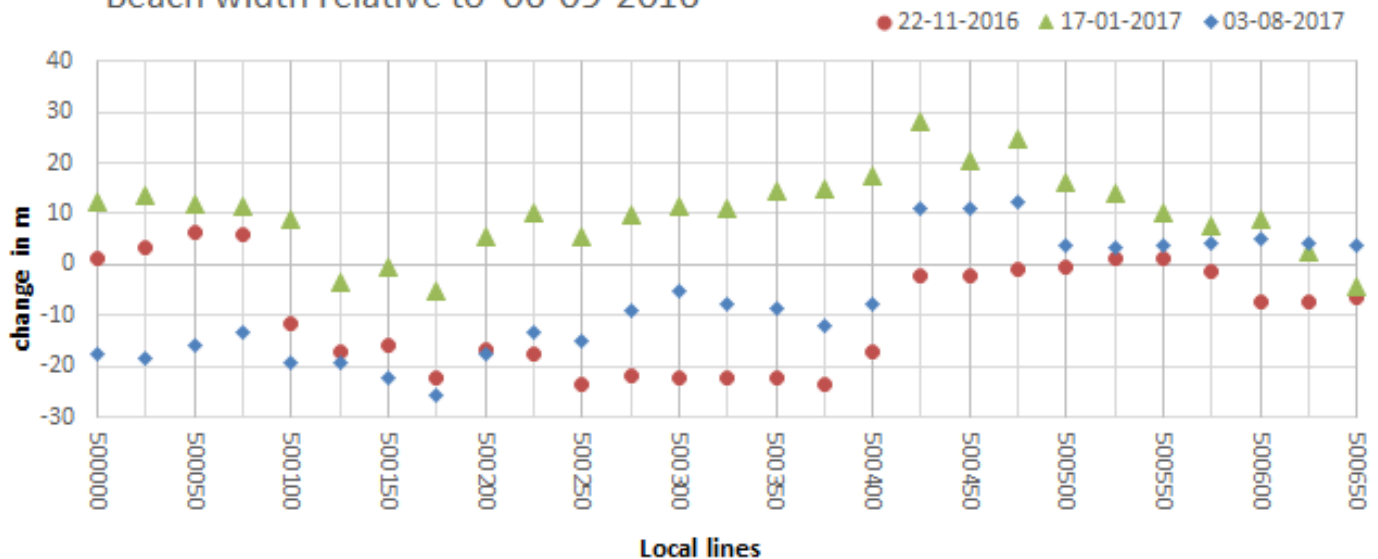
Beach width relative to 06-09-2016

Figure 6.7: Beach width boundaries have earlier been set as the horizontal difference between MCP and MDP for all lines measured. By subtracting the MDP from the MCP a positive horizontal length is found, here defining the beach width.

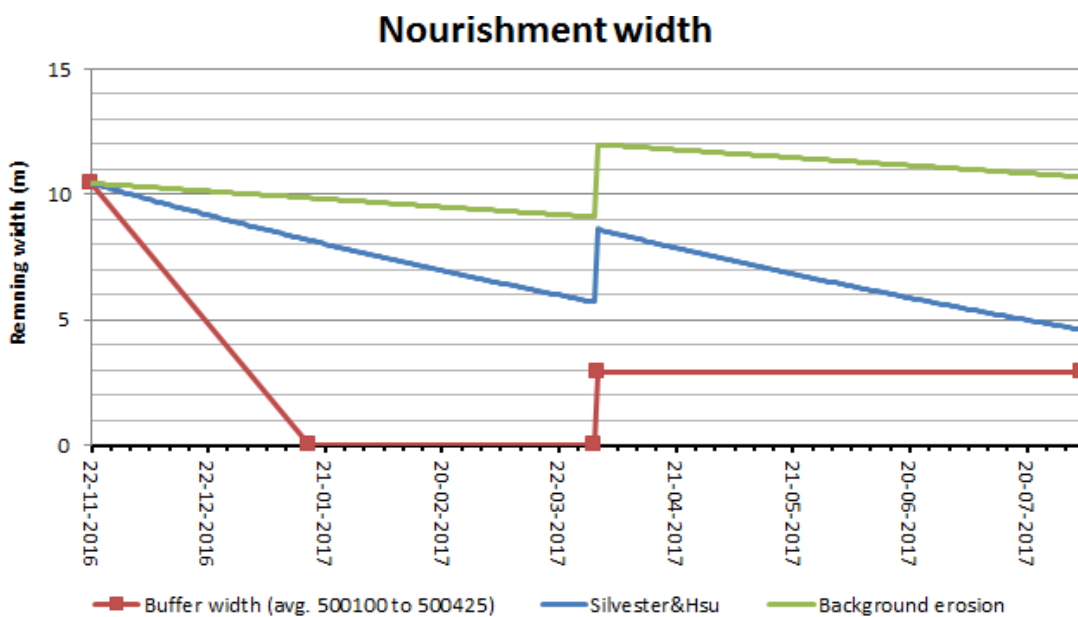
Figure 6.8: The figure presents the nourishment width at the nourished stretch for both measured, theoretical and if inly background erosion had been present.

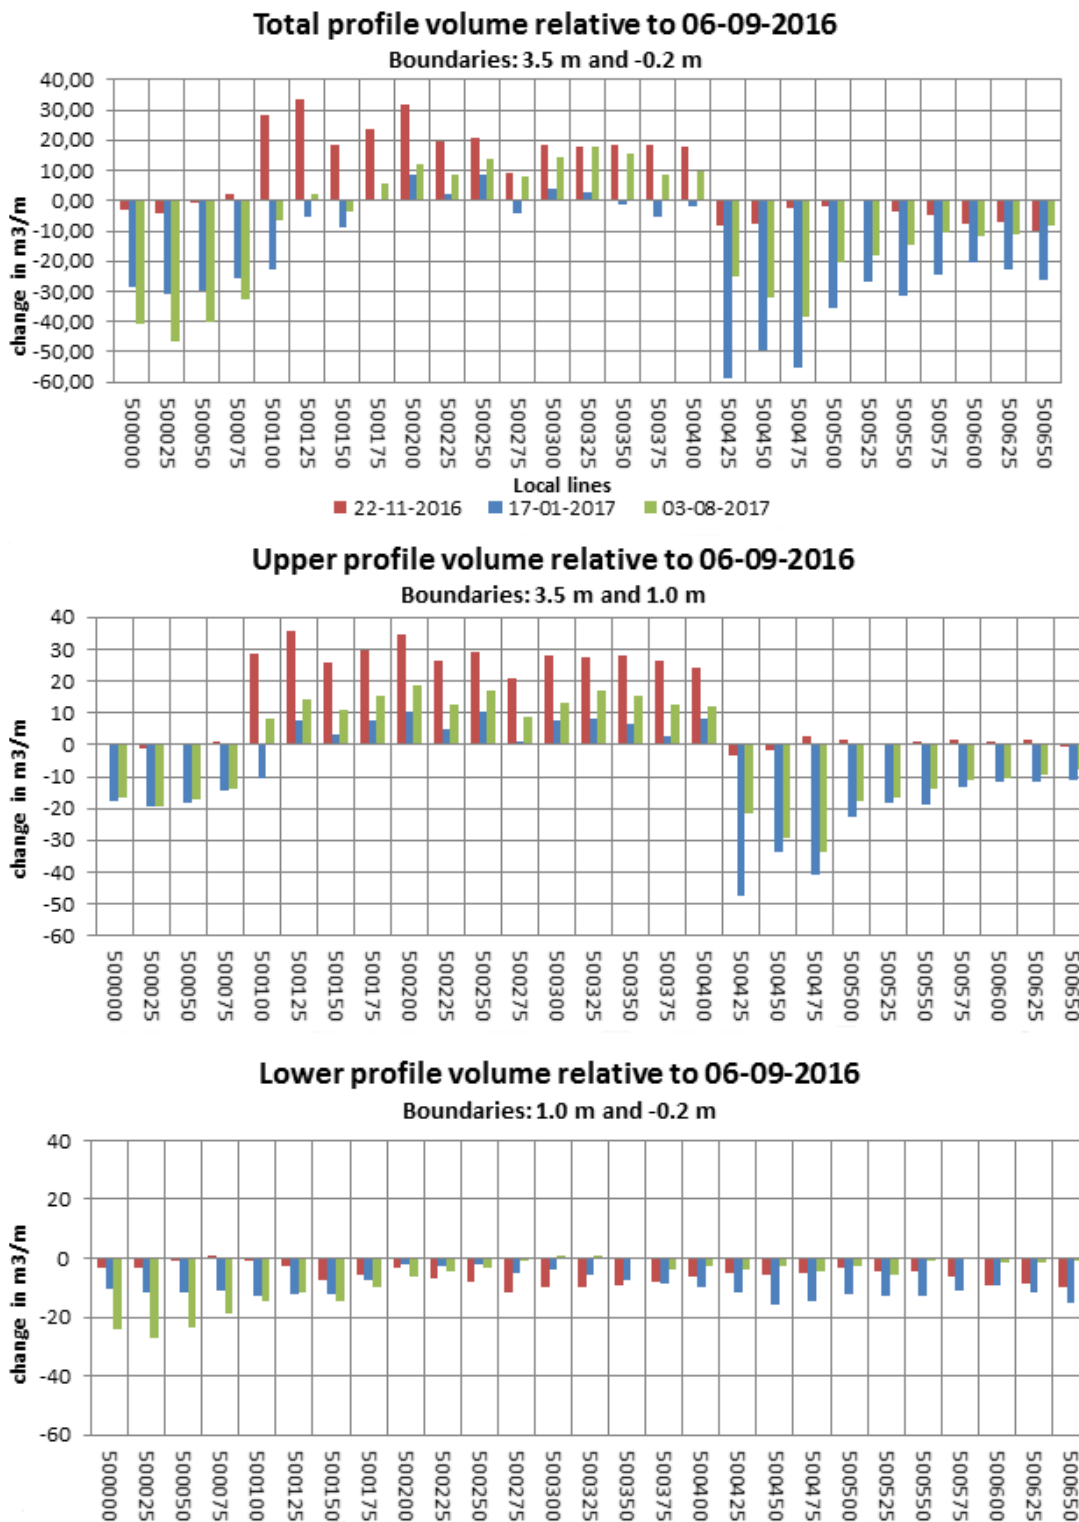
Figure 69: The volumes have been calculated from MorphAn. In the coastal development tool an MCP is returned between 3.5 and -0.2 m. The volumes shown here is the volume from the inland fix point at 900 meters and seawards between the heights of 3.5 m and -0.2 m. All sand lost or gained, above 3.5 m and beneath -0.2 m is lost in this definition. The volume extension to the inland reference point at 900 meters was done manually in excel.

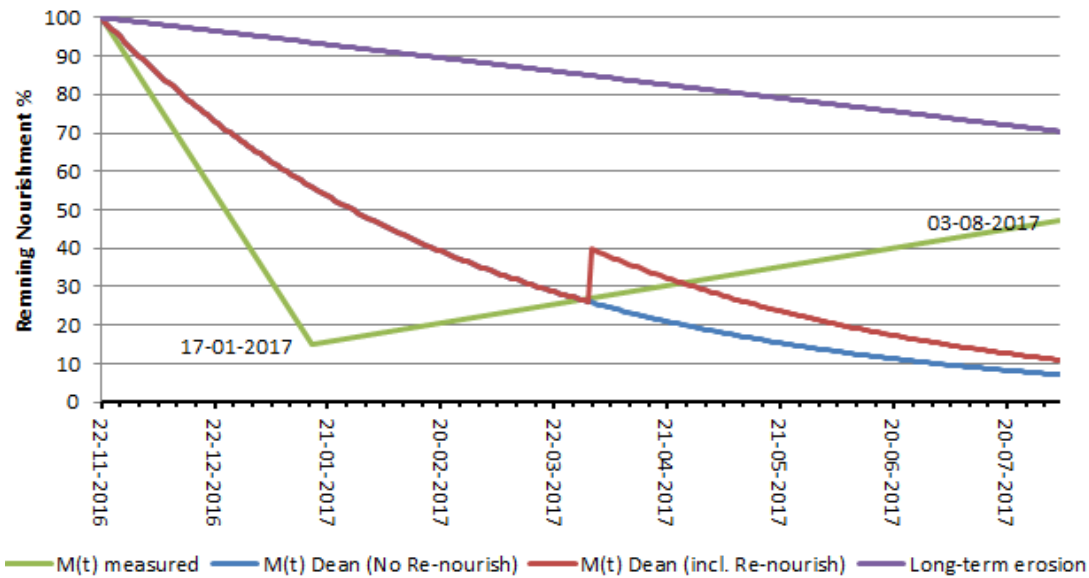
Figure 6.10: The figure presents two diffusion models, one including the re-nourishment of 1700 m³ set to be finished on April 1 2017 and a model which does not include it. The Measured Volume is found as described in the text. Measured Volumes were found in MorphAn between 4 m and -0.2 m, to an inland fixed set to 900 m, and have been normalized to percentage.
