# Beach nourishment effects

Hald beach - Denmark 1984

<b>Report</b>	<b>Analysis of the effect of a beach nourishment, Hald beach, Denmark</b>
Author	Henrik Vinge Karlsson, Per Sørensen
Keyword	Beach nourishment, Coastal protection, Building with nature, Hald beach
Distribution	<a href="http://www.kyst.dk">www.kyst.dk</a> , <a href="http://www.buildingwithnature.com">www.buildingwithnature.com</a>
Referred to as	Kystdirektoratet (2020), Beach nourishment effects - Hald Beach, Kystdirektoratet, Lemvig.

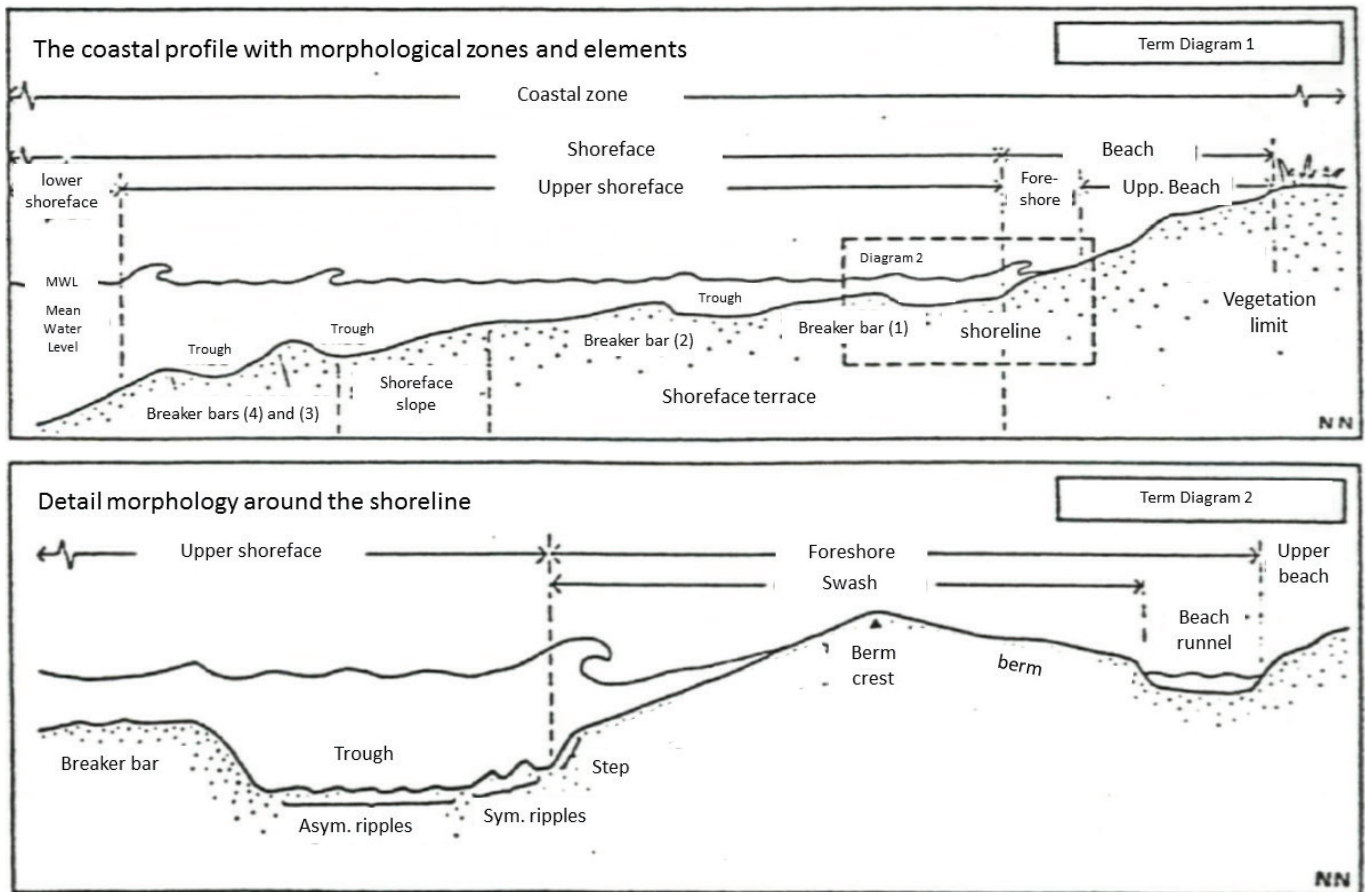
Figure 1.3: Showing an idealized coastal profile and its characteristics. Modified from (Nielsen and Nielsen, 1978)

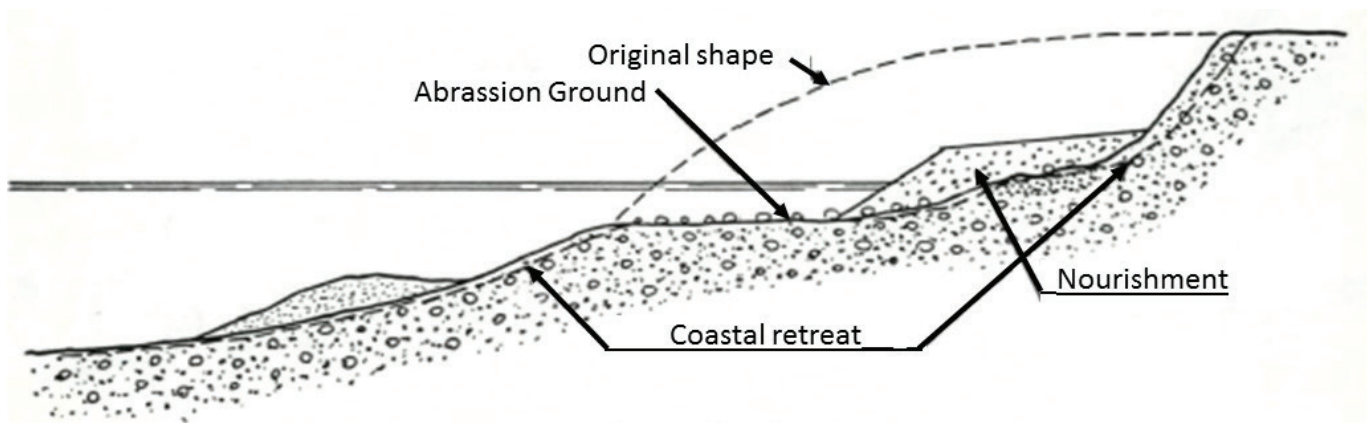
Figure 14: Conceptual figure of the coastal retreat and the nourishment placement. The abrasion grounds are formed as the moraine cliff retreats. The bottom layers consists of hard bottom layers of clays, till and stones, which are left from the moraine deterioration as they are too large for waves and water to move. Other elements exist in the shoreface but are more temporary in nature.

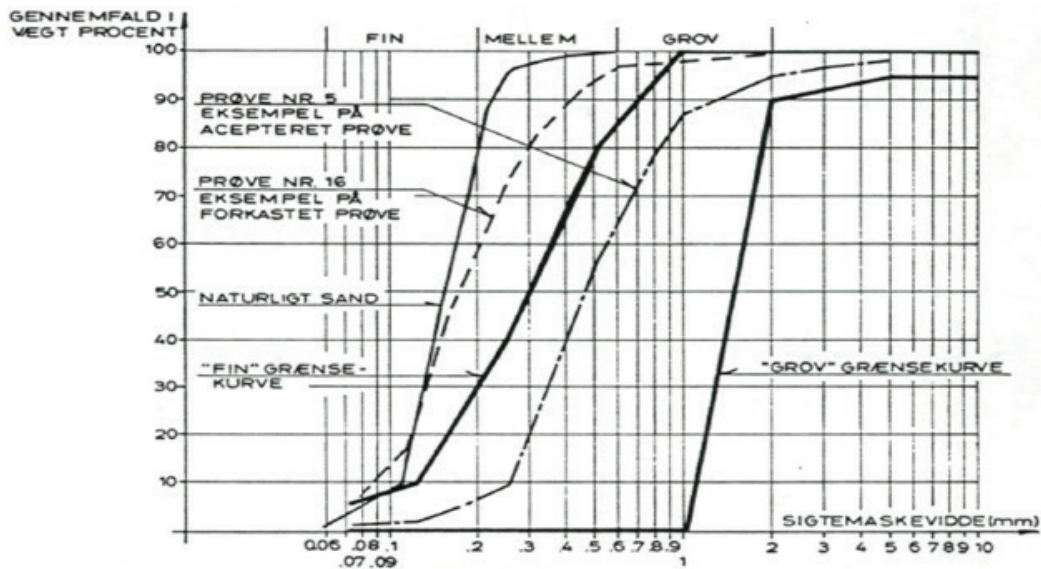
Figure 15: Grain analysis of the natural sediment of Hald beach, and examples on grain analysis from the dredger. A "fine grain" and "coarse grain" limit have been set, to ensure sediment was between the desired values. The limits are shown with bold curves. The solid curve furthest to the left is the native sand.

The nourishment volume was based on the estimated annual sediment transport along the stretch, which was between 20,000 and 25,000 m<sup>3</sup>/year. The nourishment sediment was required to be slightly coarser than native sediment. Sediment for the nourishment was dredged from the area known as "Grønne revle", WNW of the Hald area. Sediment was dredged below the -8m depth contour. Grain size distribution was tested for every 3,000m<sup>3</sup> and the plant residue content was tested for every 6,000m<sup>3</sup>. Most tests showed that the nourishment sediment was within the desired grain size and the averaged d50 for the nourishment sediment were 0.4mm while the native had a d50 of 0.15mm.

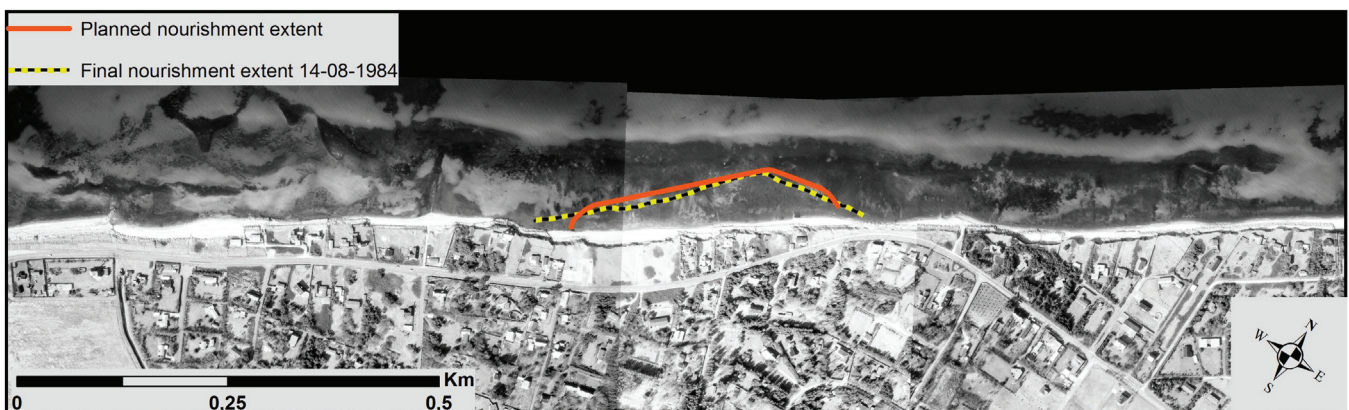
Figure 1.6: The position and extent of the planned nourishment and the actual nourishment extent.

The planimetric shape was planned so that the orientation of the new shoreline would be perpendicular to the predominant wind and wave directions. This planform requirement was based on the assumption that a perpendicular setting to the oncoming waves would reduce diffusion time and possibly only result in slight leeside erosion of the NE-end. The full extent can be seen in Figure 1.7 while the planned and final planimetric extent of the nourishment is shown in Figure 1.6.

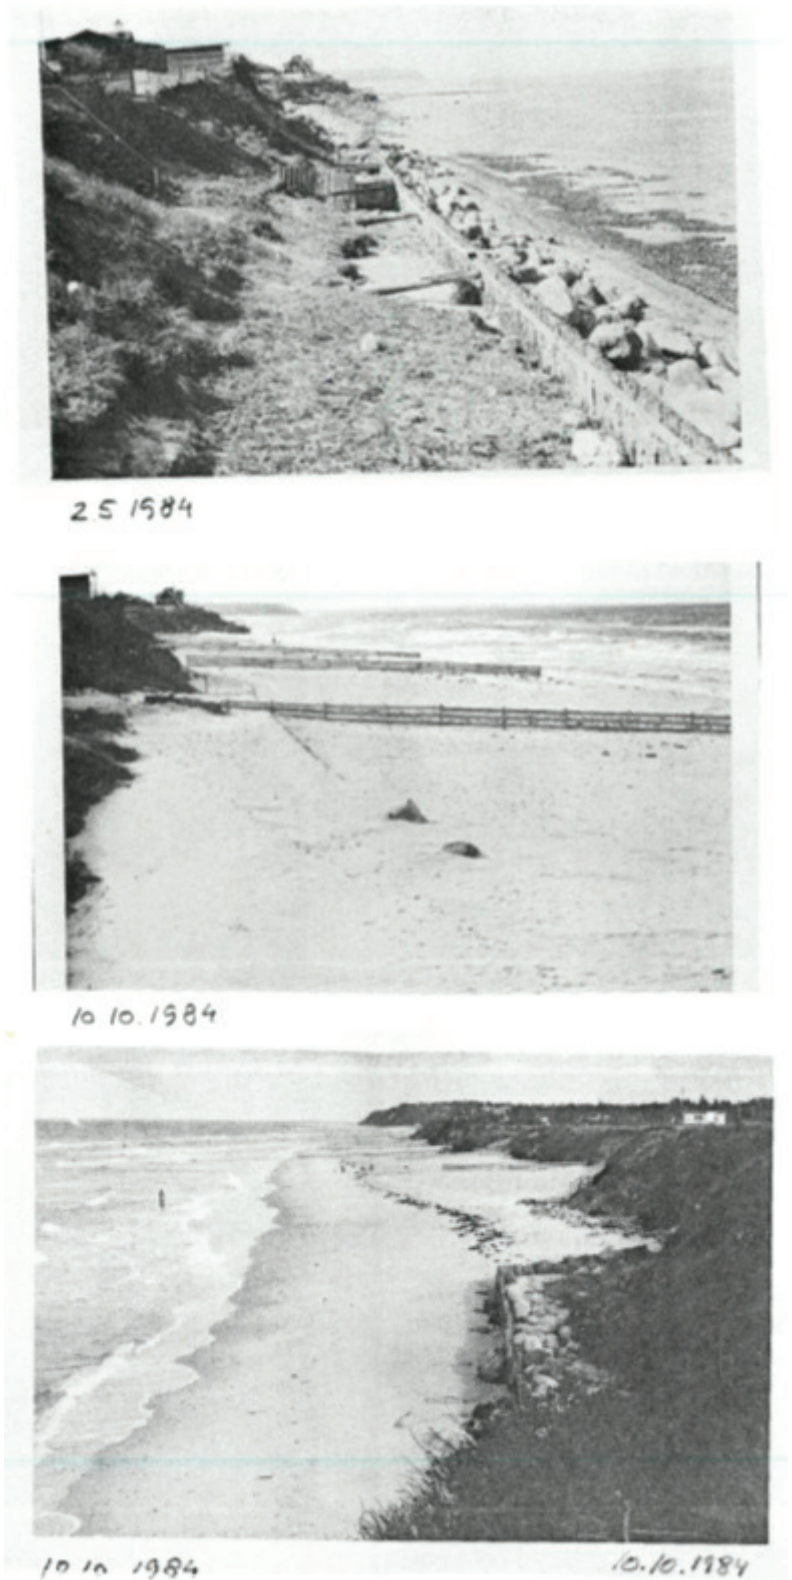
Figure 1.7: Photos before and after the nourishment. The two top photos are from NE of the nourishment facing SW - The house in the upper left corner (Nøddebovej 166) can be used as reference point between photos

Bottom photo is from Nøddebovej 166 facing towards the NE and shows the extent of the nourishment.

In order to control aeolian sediment transport, wooden windbreaks were erected and marram grass was planted, as well. The windbreak fences were shortened during the monitoring period as the shoreline receded. Photographs before and after the nourishment are shown in Figure 1.7.

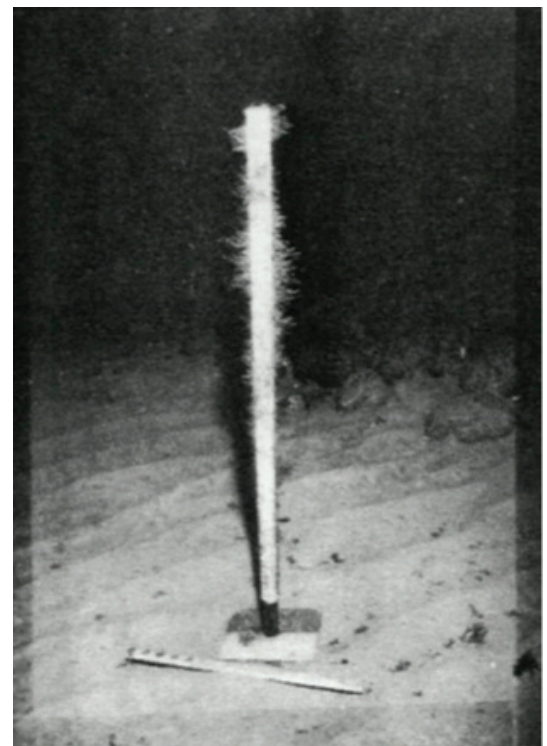
Figure 18: Pile with plate mounted. Found at 3 m depths and as seen, there is a rocky section in the background.

It was expected that the nourishment sand would redistribute over time, and it was assessed that the main transport would be across the shoreface. Therefore, constructions for underwater measurements of the maximum erosion depths were installed. Steel piles were rammed into the seabed, and a flat plate was placed on top of the piles, making downward movement possible. Maximum erosion depths could hereby be found between surveys, as a downwards movement indicated erosion since last inspection. Of course, the plate could not adjust to accretion, but sediment overlaying the plate could be measured and accumulation was obvious. Originally, three station lines with piles for every 25 meters (300 meters across) were installed. Out of the 36 piles, only two were followed during the monitoring period, as the remaining were damaged by severe weather conditions.

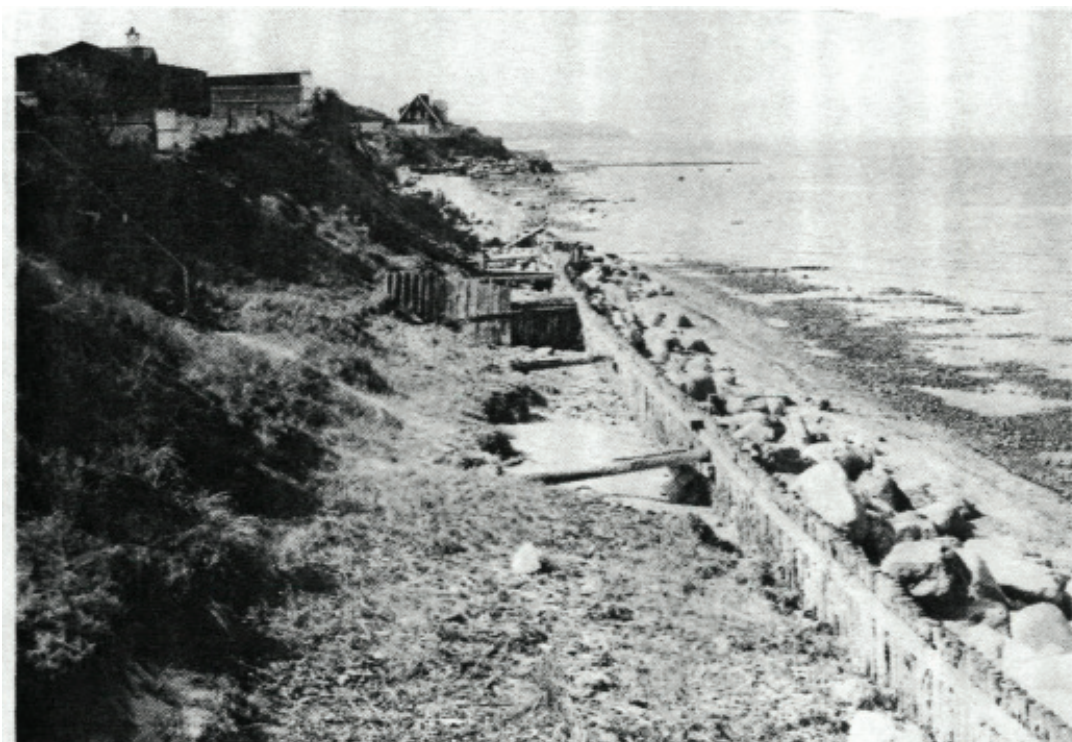
Figure 2.4: Image taken from the original fix imagery point C. Looking from NE towards SW - The old pier can be spotted in the shallow water to the right of the house at Nøddebovejen 166 (May 1984). Photograph is from (Fællesudvalget, 1987)

The beach width ranged between 0 m and 15 m before the nourishment. Beach material mainly consisted of gravel and pebbles with sporadically distributed larger stones. At the middle section in Box B, where no revetments were found, narrow sand segments were present – see Figure 2.4.

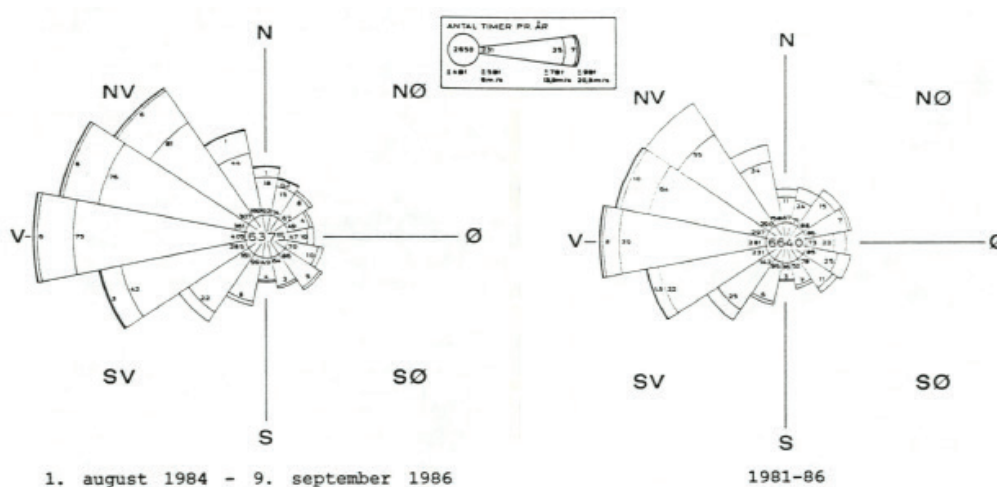
Figure 3.1: Wind roses from Spodsbjerg lighthouse, both from the monitoring period (Left: 1 august 1984 - 9 september 1986) and a 5 year period for comparison (Right: 1981-1986).

Wind conditions are presented in Figure 3.1 and Table 3.1. Here, wind measurements from the local wind gauge and Spodsbjerg Lighthouse are presented for the study period between 16/8/1984 and 7/9/1986 and two reference periods (1981 - 1983 and 1981 - 1986) in Table 3.1. Reference periods are included to facilitate comparison with wind conditions during the monitoring period.

Wind speed and direction were observed visually three times a day (08:00, 14: 00 and 21:00) for Spodsbjerg lighthouse, 4 km SW of the nourishment stretch. These measurements were conducted by the metrological institute and the period between 1981 and 1986 was included in the original report. An automatic wind gauge was installed at Hald Beach and it measured from 1/8/1984 to 9/9/1986 and was used as reference to the lighthouse observations.

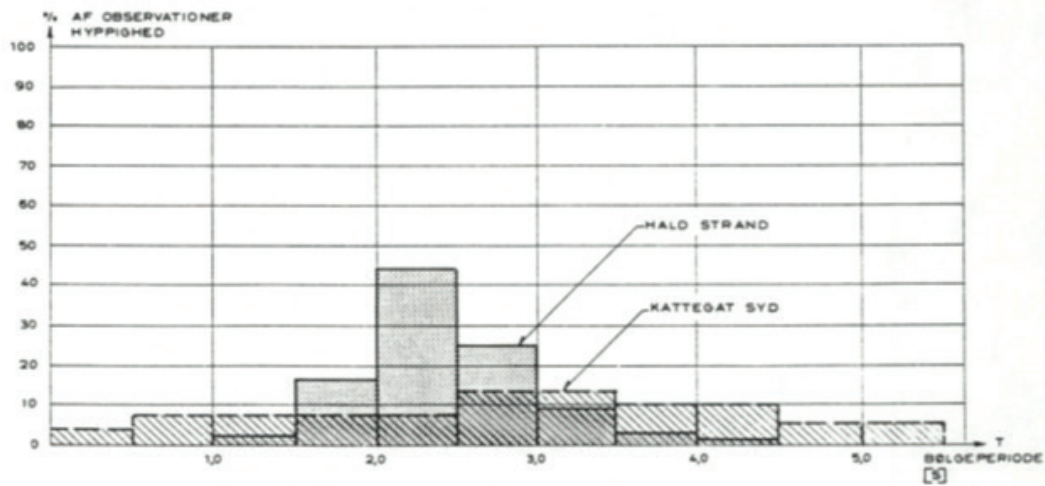
Figure 3.2: Frequency distribution of wave periods, observed at the lighthouse ship Kattegat S (1962-1971) and Hald Beach measurements (1984-1986). The Y-axis shows the % of observations while the X-axis shows the wave period.

The two sets of wave measurements are presented in Figure 3.2. Short period waves (below 3s) are dominating the stretch. This corresponds with the short, but fast waves, often observed, which have developed over short fetches. However, in the original report, it was noted that there could have been larger waves, but they may have been filtered out in observation, as they were overtopped.

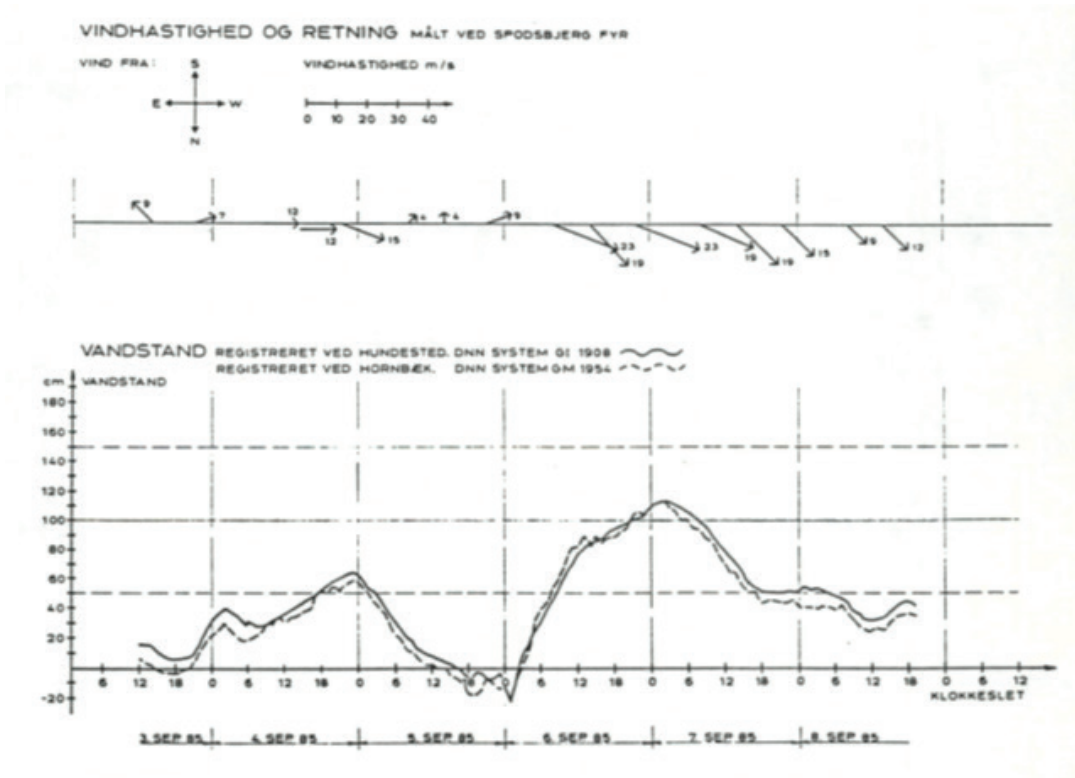
Figure 3.3: Wind speed, Wind direction and water level measurements from 3<sup>rd</sup> of September 1985 to 8<sup>th</sup> of September 1985. The figure is directly depicted from the original report without translation, to avoid loss of information in the graph.

On the 5<sup>th</sup> of September 1985, a low-pressure system appeared and was slowed by the Norwegian highlands which made it circulate for the following three days. This meant that on the 6<sup>th</sup>, wind strength went from 5 m/s from SE (offshore) to 27 m/s from NE (longshore), creating a wave front almost parallel to the coast. The storm exceeded 20 m/s for 26 hours, which was followed by wind speeds of 10 m/s for more than five days. Wave heights were not recorded during the storm, as the wave buoy was non-functioning, but from visual inspection  $H_{max}$  was estimated to >2.5 m. The loose sediment on the shoreface must therefore have undergone redistribution, but a net transport direction was difficult to distinguish. The highest water level was measured to be +1.2 m above DNN, but this peak did not occur until one day later than the storm peak. If a more northerly or westerly wind had prevailed during the storm, the water level would potentially have been higher.

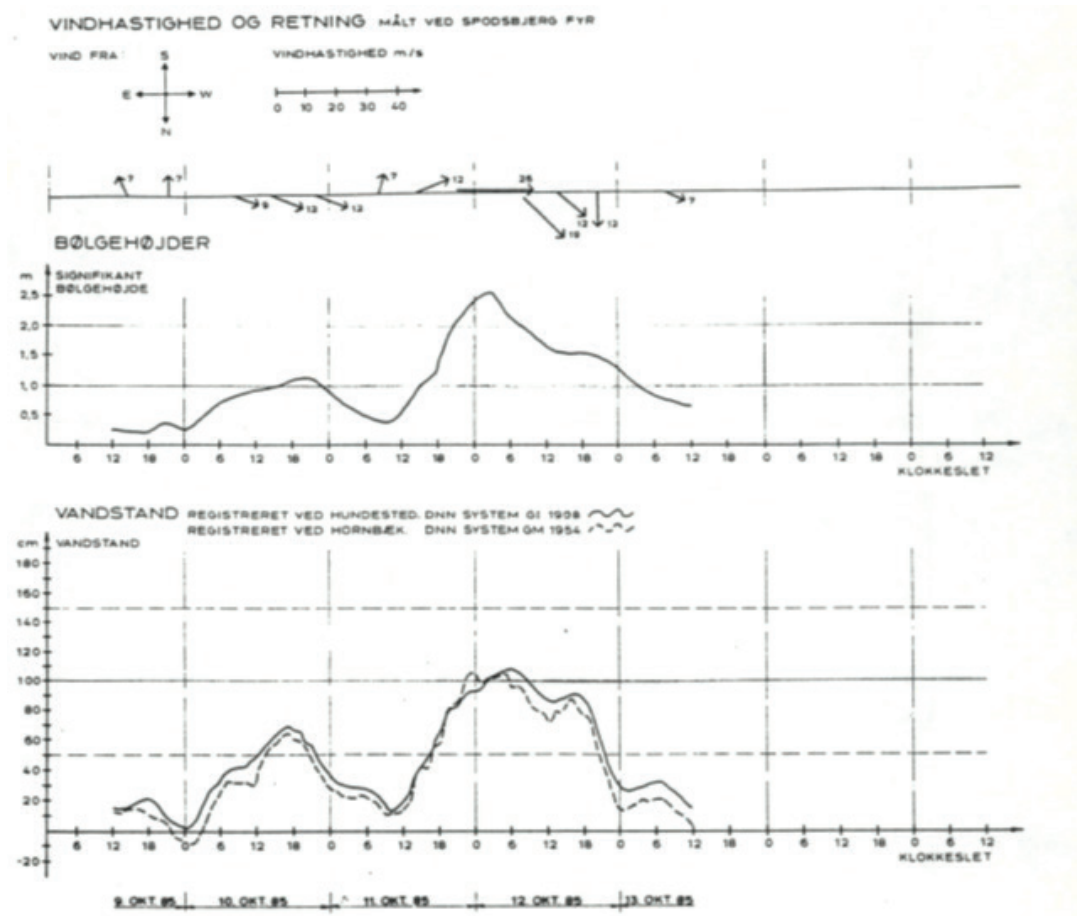
Figure 34: Wind speed, wind direction and water level measurements from 9<sup>th</sup> of October 1985 to 13<sup>th</sup> of October 1985

During the first 24 hours, longshore transport was towards NE, decreasing to almost none, while at the end of the period a smaller energy component and shift in wind direction meant longshore transport towards the SW. High-water level reached 1.06 m and peaked half a day after the storm peaked.

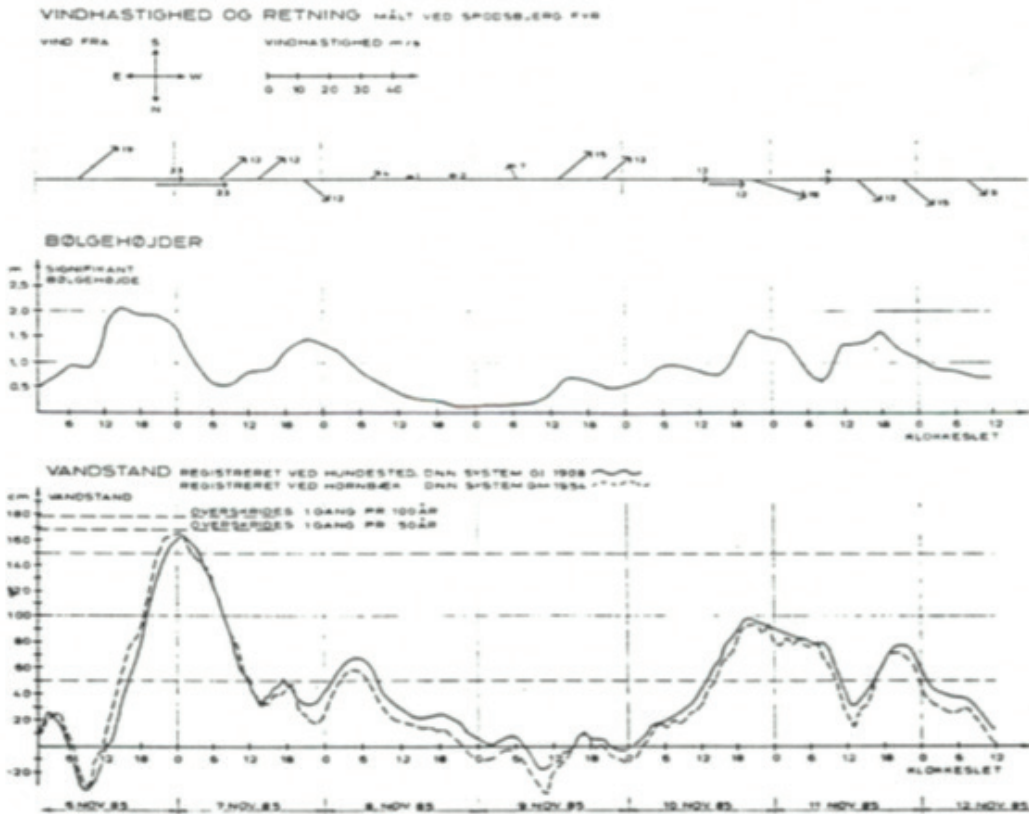
Figure 3.5: Wind speed, wind direction and water level measurements from 6<sup>th</sup> of November 1985 to 12<sup>th</sup> of November 1985

Wind speeds during this event were the lowest of the three incidents and includes multiple peaks at 20 m/s from a westerly direction. During the storm peak, the waves took an oblique angle to the coast normal and would therefore be expected to have refracted in the nearshore at the coast. However, the longshore transport must have been towards the NE. The atypical circumstance for this scenario was the extraordinary high water level at +1.62 m, which was equivalent to a 50-year return event. The high water event is explained by the mass of water being pressed from the North Sea into Kattegat in combination with wave setup at the shores. The high-water peak was found again after the storm peak. As the coastline was still affected by swell waves during the high water peak, this is expected to explain the acute erosion in the cliffs around the nourishment stretch during the storm.

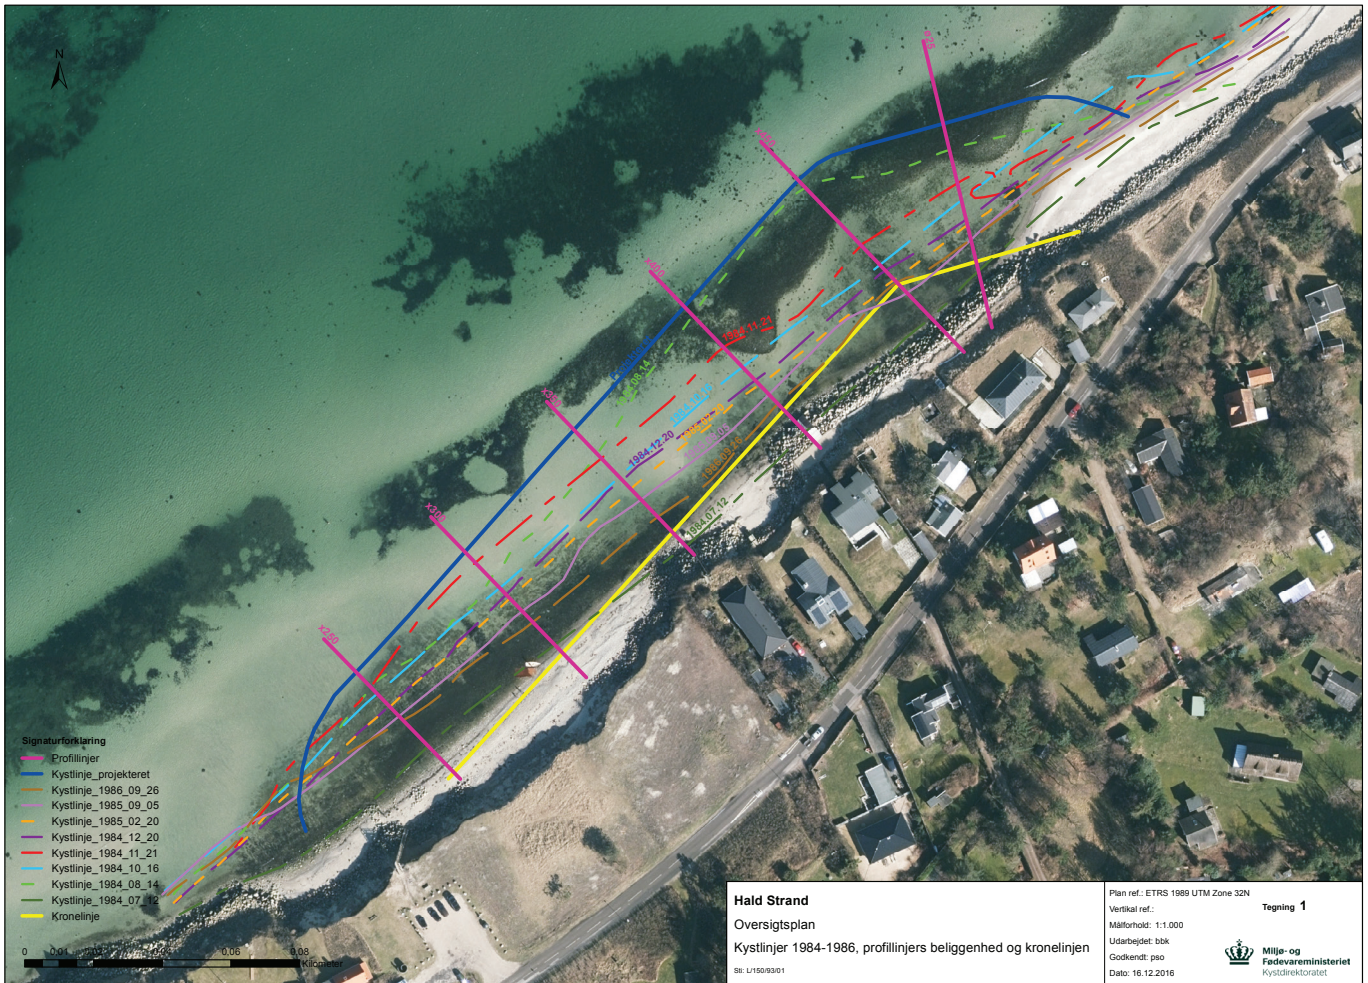
Figure 36: Showing the area distribution and changes in the shoreline over time. Profiles are shown in Figure 3 4

As seen in Figure 3.6, the shape of the nourishment was close to the planned trapeze shape, but did not extend as far seawards as planned. This was partly due to natural equilibrium processes and reshaping of the nourishment planform, which took place immediately after nourishment.

From September 1985 until September 1986, the nourishment planform did not change significantly but larger and more widespread erosion is found in the shoreface, which is also seen from the profiles in Figure 3.7. The beach was affected by ice from December 1985 until February 1986, which resulted in erosion patterns similar to those found in the winter period 1985, when erosion increased in the shoreface. The profile measurements from 5-9-1985 and 26-9-1986 in Figure 3.7 suggest a longshore sediment redistribution in the bars and shoreline during this period. Generally, the profiles show retreat above the 0 m contour during this period. The shoreline position also retreats slightly between 05-09-1985 and 26-09-1986, except at line X450 and in the SW-corner of the nourishment stretch where the shoreline advances, see Figure 3.6.

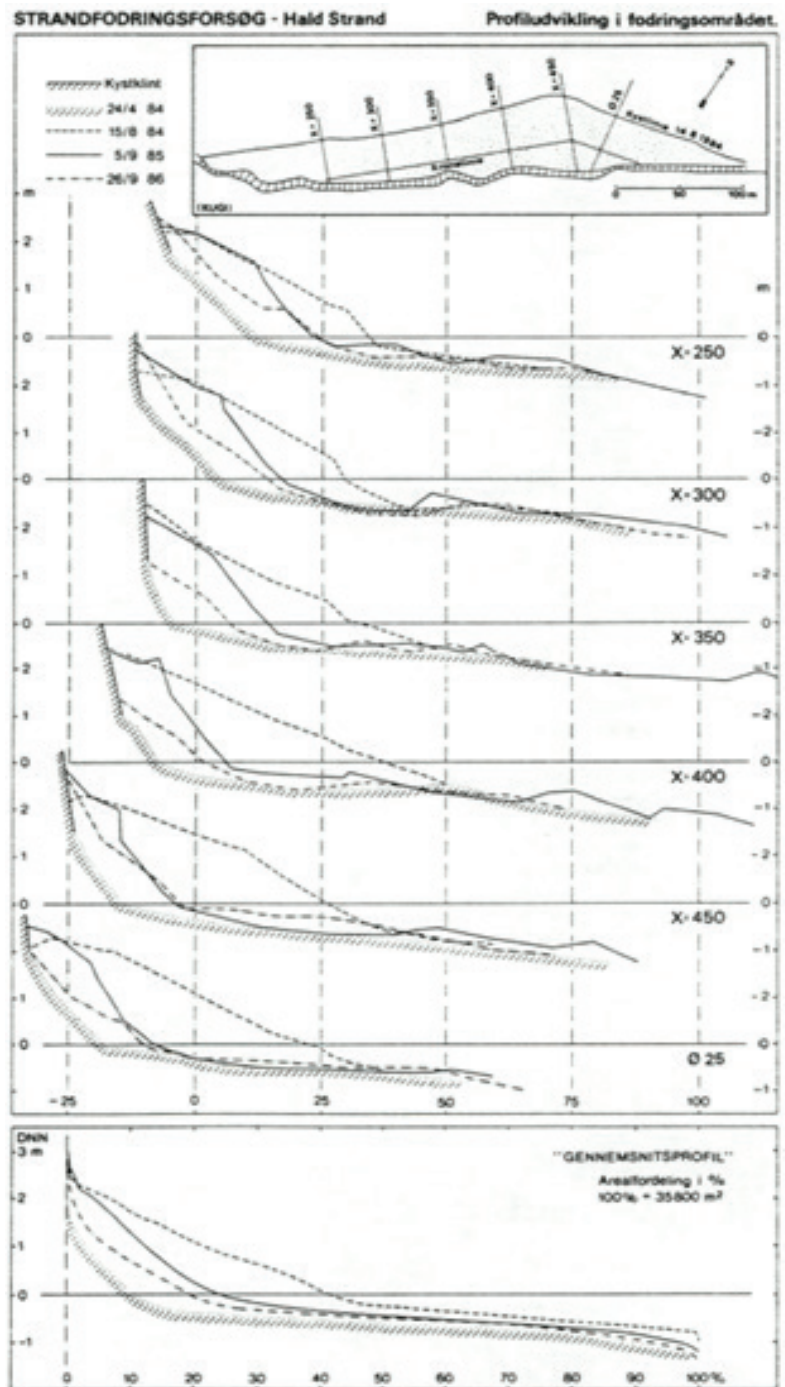
Figure 3.7: Profile measures for the nourishment stretch are presented for all with dates, together with the avg. profile in the bottom graph.

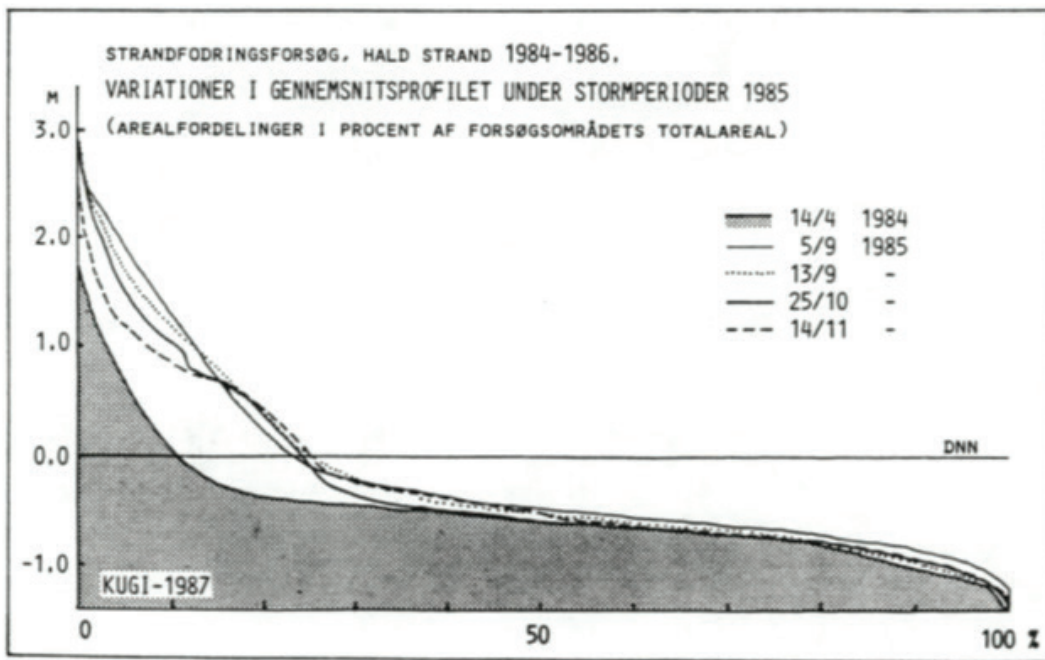
Figure 3.8: Variations in the averaged profiles during storm periods in 1985. Distribution of area in percentage between contours.

The storm between the November 6<sup>th</sup> and 7<sup>th</sup> did not have the same wave intensity or energy as the September and October storms, but retreat in the upper beach and nourishment was of the same magnitude, as seen in the earlier storms. The explanation could be the unexpected high water level, which reached 1.62 m above DNN (50-year event at the time) during the November storm. If we consider the average profiles of 25-10-1985 and 14-11-1985 in Figure 3.8 we will notice that retreat is only found above  $\approx 0.8$  m contour, while profile height increases and advances slightly below the 0.8 m mark. As the water level was higher during this storm event, than during the other storm events, it may have given way for erosion in a profile above past water levels, which peaked at 1.16 m and 1.06 m in September and October, respectively.

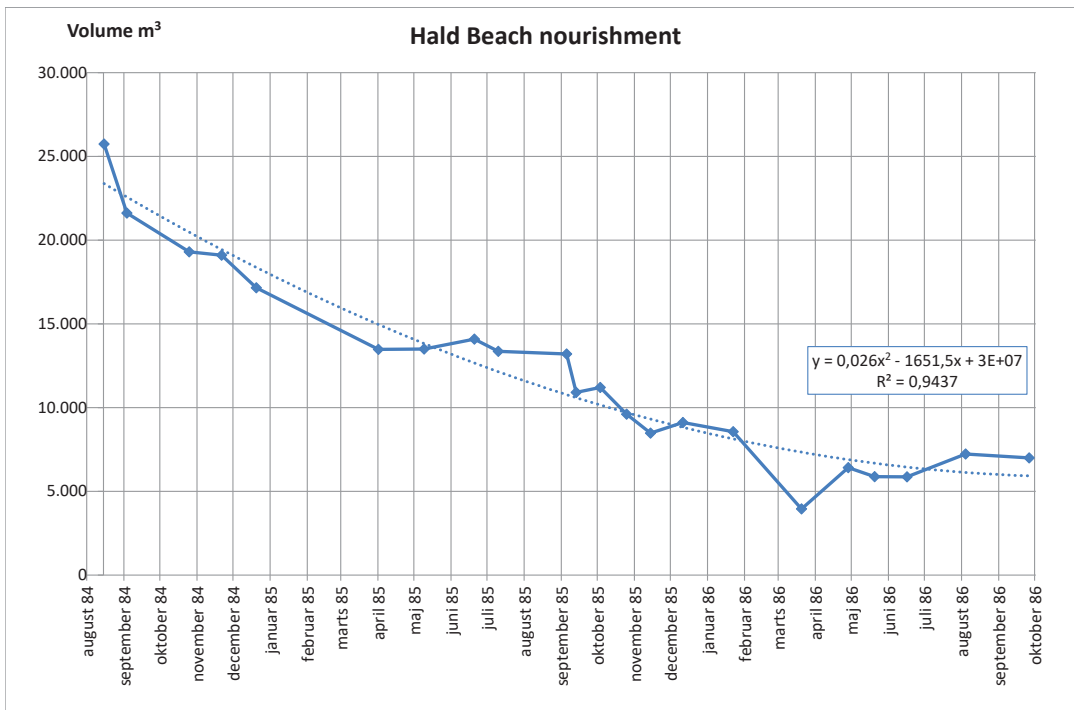
Figure 39: Volume development and polynomial trend line

Looking to the full period from 1984 to 1986, it is obvious that the general trend is erosive (Figure 3.9). The best trend fit is a polynomial, and it describes the diffusion of the nourishment volume with a R2 value at 0.94. Smaller accumulations exist between some measurements. Accumulation zones can be determined between all measurements and the erosion/accretion is presented in Table 3.4. The accumulation is mostly due to the dynamic behavior of the profile as deposition of eroded material in berm or breaker bars, while erosion is present within the whole area dependent on time. This was also noted in the profile analysis.

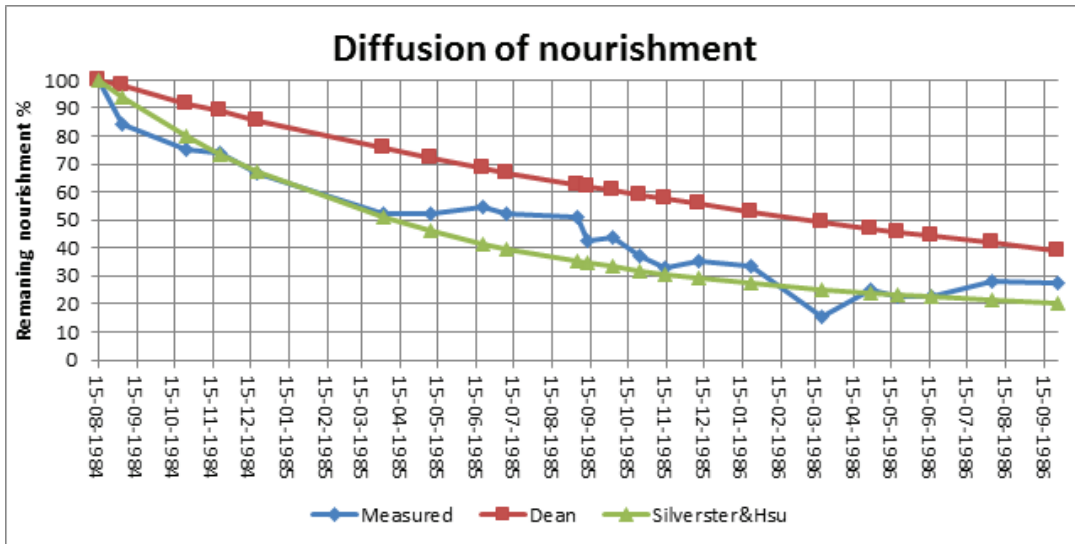
Figure 310: Visualizing the normalized decay projections as well as the true volume decay in percentage of original volume.

The model presented by Dean shows to underestimate the volume decrease in the case of Hald beach. The under-prediction is around 13 % when comparing the volumes on September 26<sup>th</sup> 1986, but it is explained by the model requirements and the decay rate. The decay described by Dean requires that the stretch has been nourished before and the diffusion is supposed to be based on earlier nourishments. This naturally also indicates that there is a continuous sediment addition in a perfect example. Per definition, this is not the case in Hald as this nourishment was the first to be made on the coast, furthermore, there was a general sediment deficit on the stretch. The diffusion rate is set at 0,45 m/y, but this retreat only describes the cliff recession and not the deficit in the shoreface and beach. The excess decrease in nourishment volume should therefore be considered in relation to the actual profile state, which was generally erosive with decreasing sediment input.

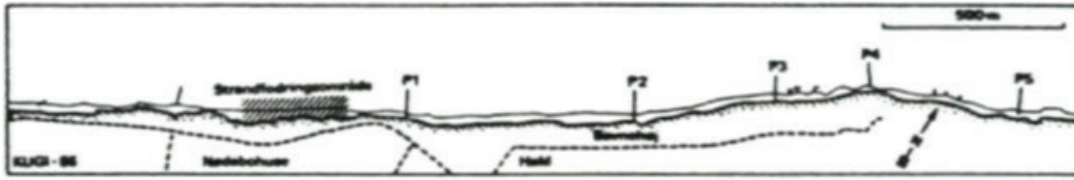
Figure 3.12: The five additional profile measurements are presented here. Notice that the nourishment stretch is shaded to the SW.

In September 1985 five additional transect lines were defined in the stretch NE of the nourishment. These were numbered P1 to P5 - profile measurements were conducted nine times and were measured between the upper beach and seaward to a depth of -1.0 m to -1.5 m, with lengths of between 70-100 m. These profile lines are presented in Figure 3.12.

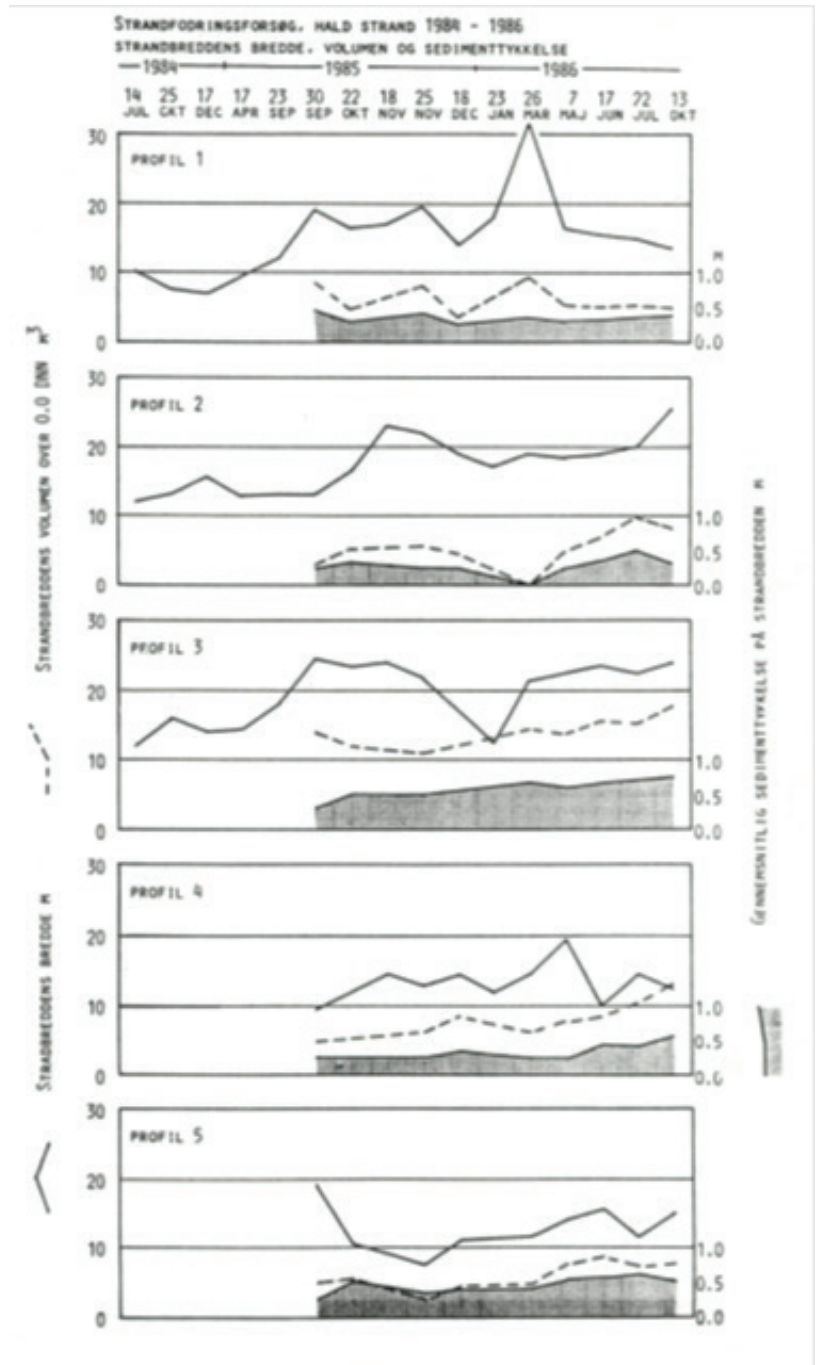
Figure 3.13: On the left y-axis: The Beach width (m) and foreshore volume (m<sup>3</sup>). On the right y-axis: Avg. sediment thickness in the foreshore (m)

The beach width, sediment volume and the average sediment thickness for the five profiles during the monitoring period are presented in Figure 3.13. Profiles 1, 2 and 3 have a comparable development in width. The shorelines at P1 to P3 advance 10 m seaward, followed by stabilization in the time after the September storm 1985. The shoreline fluctuates around a stable position for profile 4, while profile 5 shows larger fluctuations for the shoreline and the storm in September 1985 resulted in a shoreline retreat of +10 m - despite this retreat, there is a slight advance during the remaining period. Additional sporadic but extensive acute erosion of multiple cliff faces was seen in the September, October and November storm events of 1985. The magnitude of these storms did result in multiple stretches being affected by erosion. This can have caused volume increase in periods following the storm due to swell waves. Beach volume increase, as well as seaward extension cannot be attributed to the nourishment sediment alone.
